ANTARCTIC TREATY INSPECTIONS 2005

Report of Antarctic Treaty Inspections undertaken jointly by the United Kingdom, Australia and Perú in accordance with Article VII of the Antarctic Treaty and Article 14 of the Environmental Protocol.

**Foreign and Commonwealth Office, London, UK
Australian Antarctic Division, Kingston, Tasmania, Australia
Instituto Antártico Peruano, Lima, Peru**

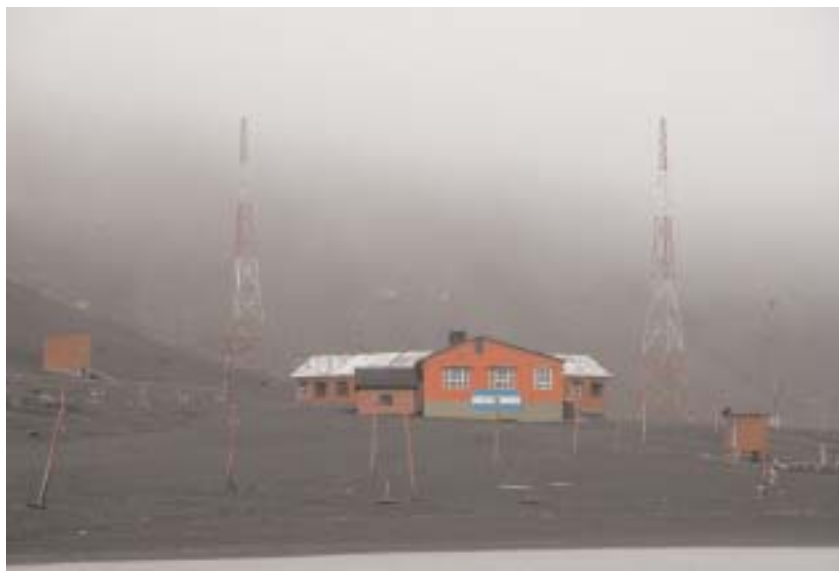
The main building Base Decepción – currently unoccupied.
