ANTARCTIC TREATY

Report of the Norwegian Antarctic inspection under Article VII of the Antarctic Treaty and Article 14 of the Protocol on Environmental Protection to the Antarctic Treaty

JANUARY 2001

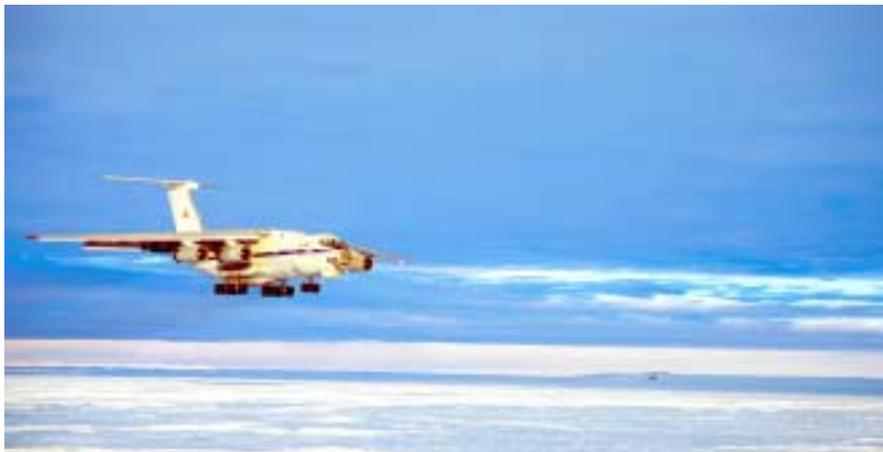
Photo 3: Aircraft landing at Henriksenskjæra (“Blue 1”)

The stations visited had not been significantly affected by tourism. However, the inspection team noted that the establishment of the seasonal blue ice runway “Blue 1” at Henriksenskjæra introduces new opportunities for tourism and non-governmental activities in Dronning Maud Land. An increased level of activity as a result of better accessibility could have a significant bearing on national programmes and station operations in this area with respect to issues such as transport and storage, accommodation, communications, search and rescue, etc. National programmes will need to consider these issues.

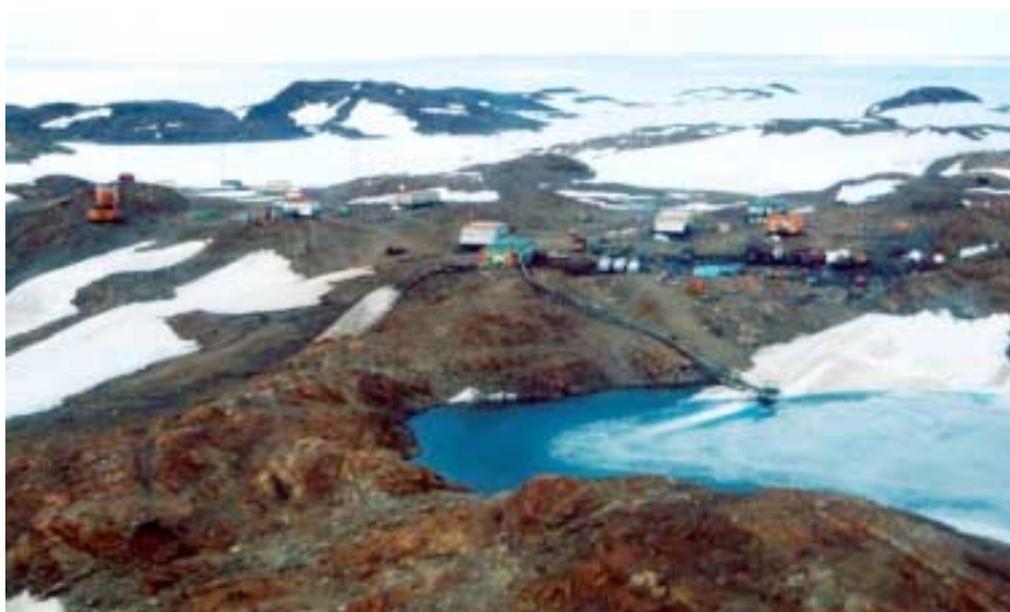
Photo 6: View of Novolazarevskaya station

The Novolazarevskaya station complex consists of a relatively large number of buildings of various sizes and varying standard spread over a large area (see Figure 3). Some of the structures are used for storage and temporary summer accommodation. Some buildings and structures are from the earlier Novolazarevskaya station.

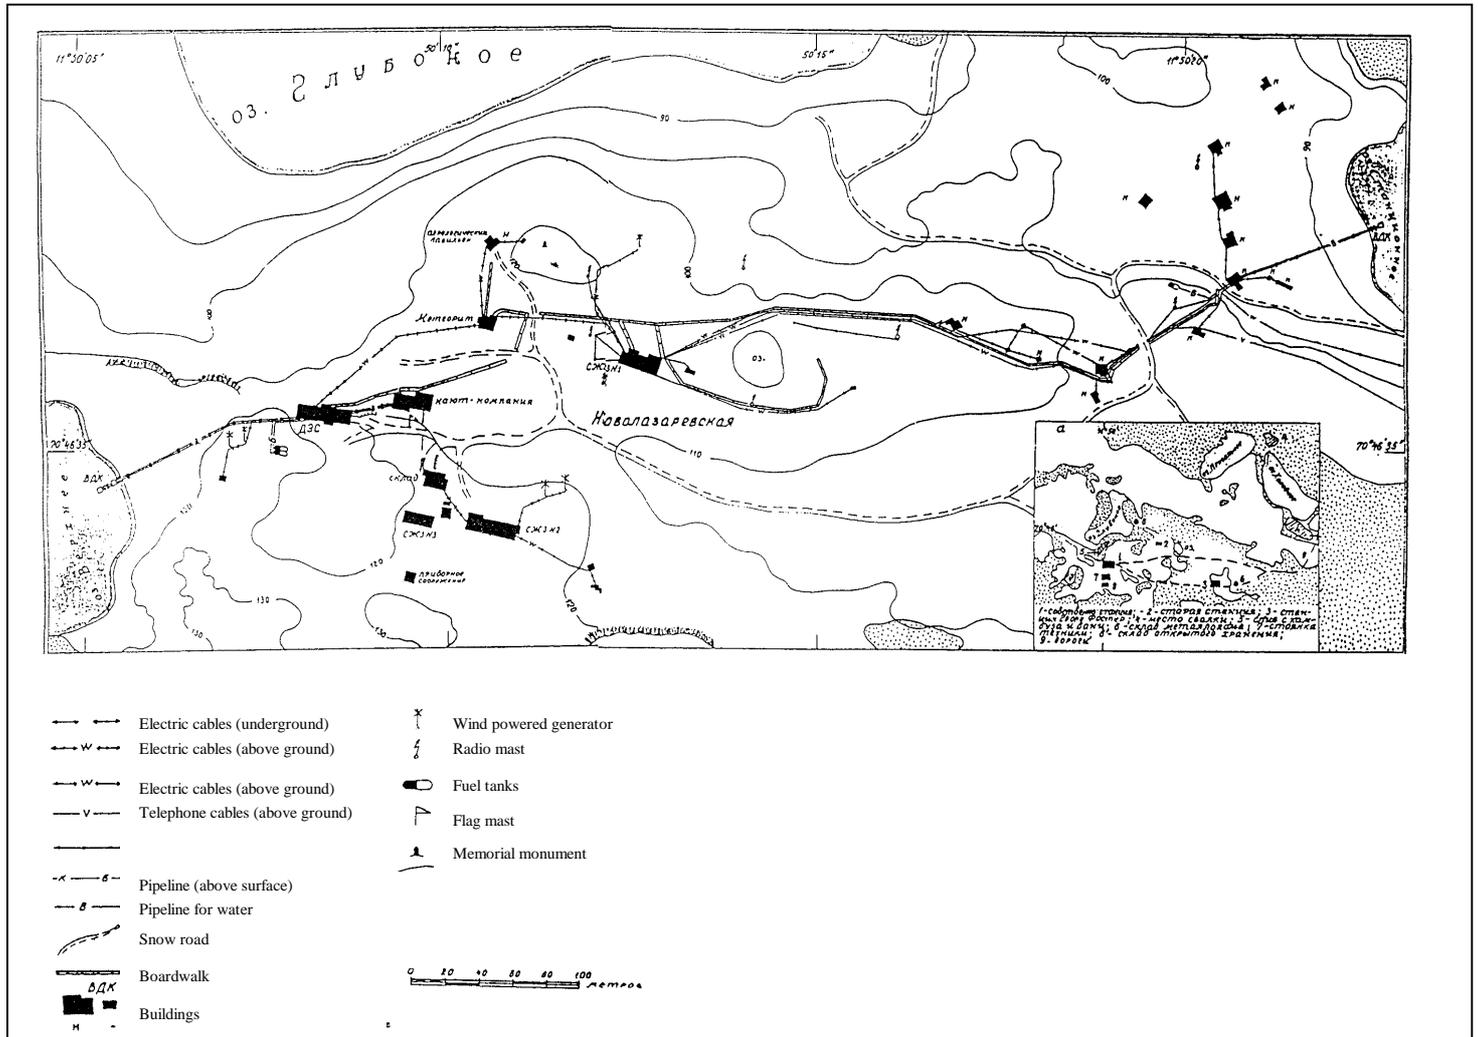
Figure 3: Layout of Novolazarevskaya

Permanent roads have been bulldozed between the various buildings in the station area, and a road also leads to the point at the ice edge where the transport route to the shelf begins.

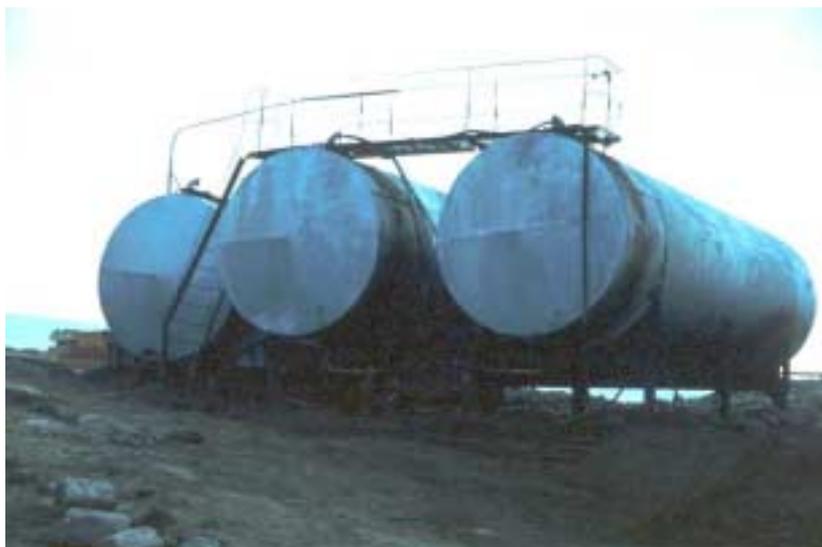
Photo 8: Fuel storage at Novolazarevskaya

tanks. There were no reports of containment systems for the bulk fuel depot, and none were observed for the tanks at the station. The inspection team observed contamination of the ground around the fuel tanks at the station. The estimated level of consumption of Arctic diesel at Novolazarevskaya during a year was 300 000 litres, including that which is used for vehicle operations.

The inspection team noted that basic fuel containment was lacking at some of the stations. Efforts should be made to rectify this as soon as possible.

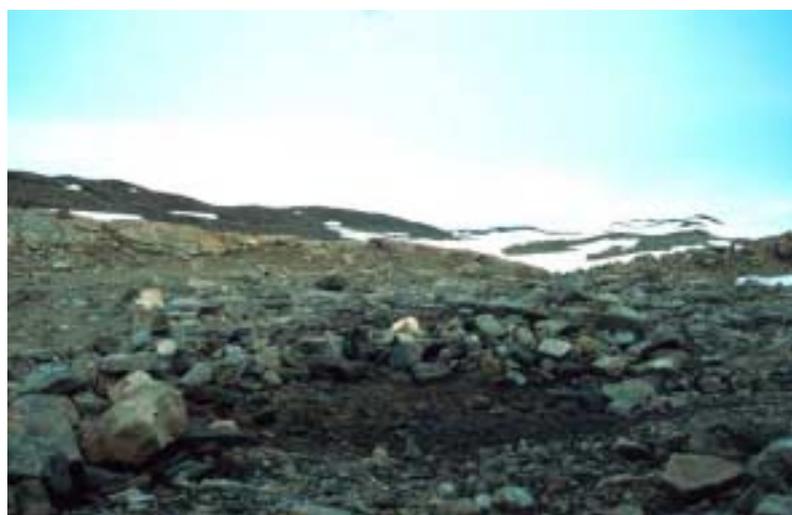
Photo 9: The site of the former Georg Forster station

The inspection team noted that all structures had been removed from the area and that a plaque commemorating the former station is the only physical installation remaining in the area. The only evidence of past activities the inspection team noted in the immediate area of the site was some indications of ground contamination. The inspection team did not inspect areas other than those in close proximity to where the station buildings had been located.

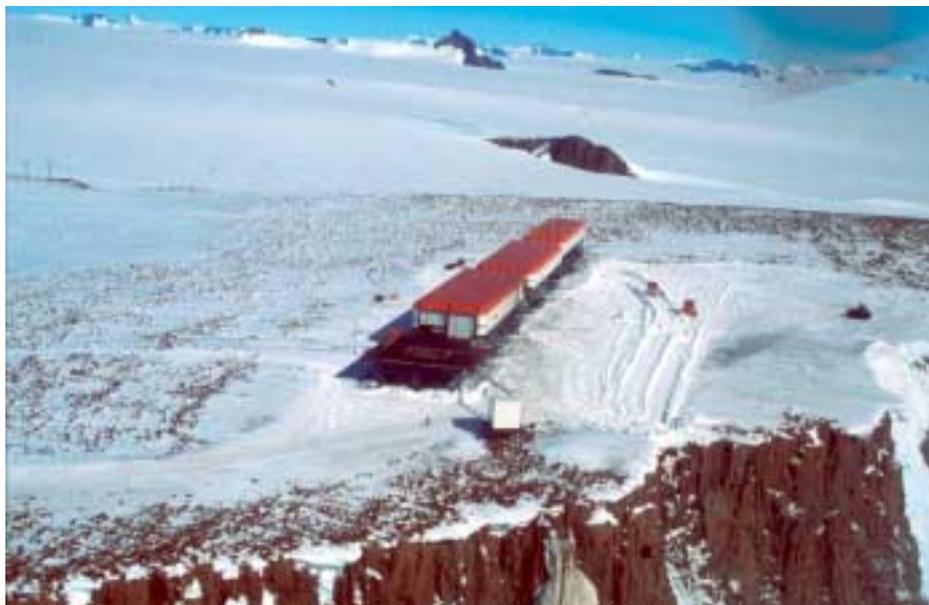
Photo 11: SANAE IV

The South African programme operates an emergency base (called the E-Base) at Blaskimen bukta. The nearest neighbouring stations are the Norwegian Troll base some 185 km away, and the German Neumayer base some 250 km away.

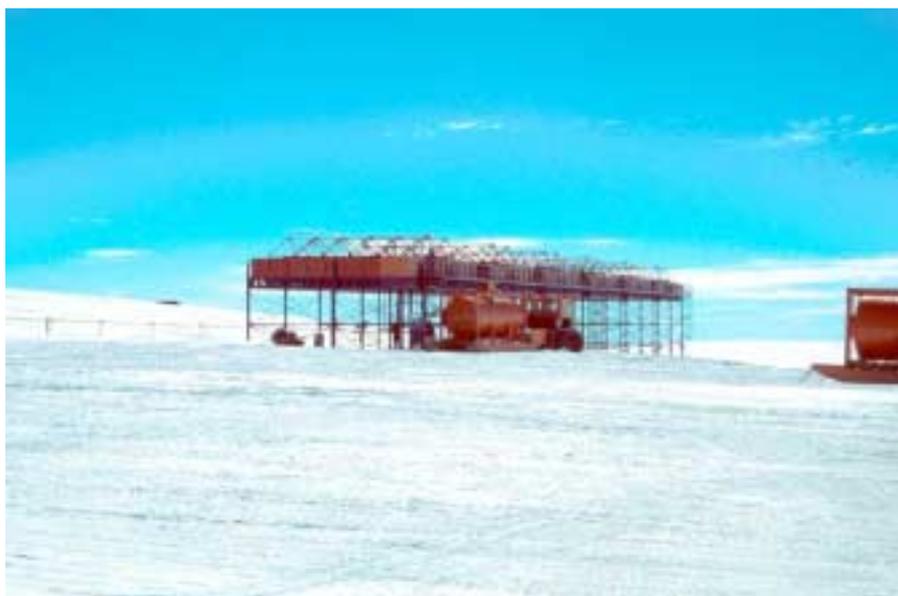
Photo 12: The bulk fuel storage at SANAE IV

No major spills were reported to have occurred during fuel transfer this season. In fact, no major spills have been reported since the 14 000-litre spill that occurred just before the 1996 inspection. Only a limited response was mounted to this spill, and there were still signs of it in the snow surrounding the fuel storage area. There was no other evidence of fuel spillage around the tanks or in any other area of the station.

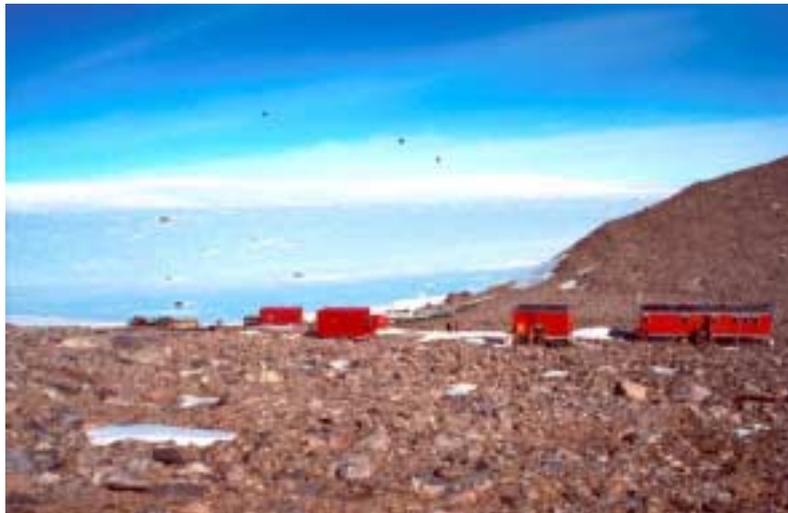
Photo 13: View of Troll station

The Troll station is located at 72°00'S 2°32'E and 1290 m on ice-free ground near an extensive blue ice field in the Jutulsessen area (Mühlig-Hofmanfjella), Dronning Maud Land. The station is located approximately 200 km from the ice edge. Troll was opened in February 1990.

The main building houses up to 10 people, and additional personnel can be accommodated in a fibreglass igloo or in tents. Personnel numbers had varied widely during the current season, with up to twenty-six people present at the station at the

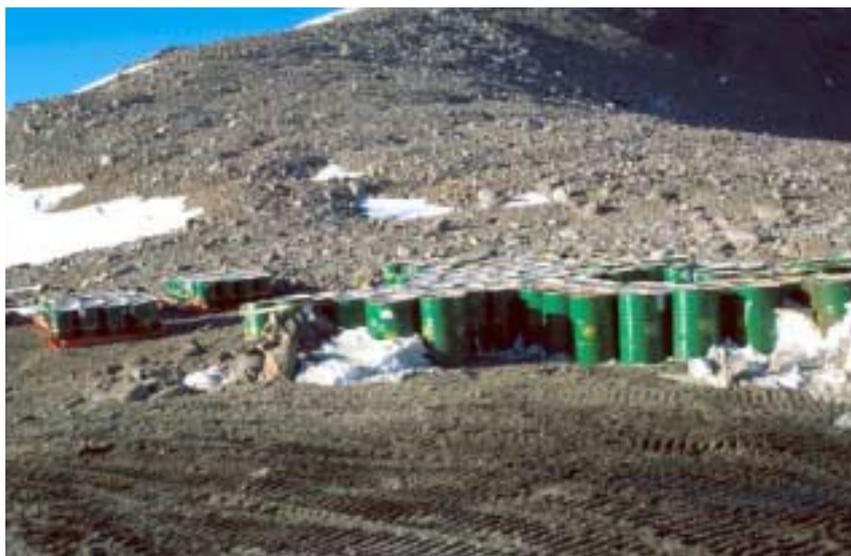
Photo 14: Fuel storage area at Troll

The fuel depot (both Jet A-1 and petrol) at Troll is currently located on the ice-free ground between the ice and the main building. Some of the fuel drums are stored on specially designed containment mats. The mats retain any small spills that may occur during storage. The mats seem to function satisfactorily. It was, however, noted that most of the drums were standing directly on the ground, with no protection. Spills or leaks from these drums could affect the freshwater source located just below the fuel storage area. It was indicated that further initiatives will be taken to secure the fuel storage depot at Troll. No signs of fuel spills were observed.

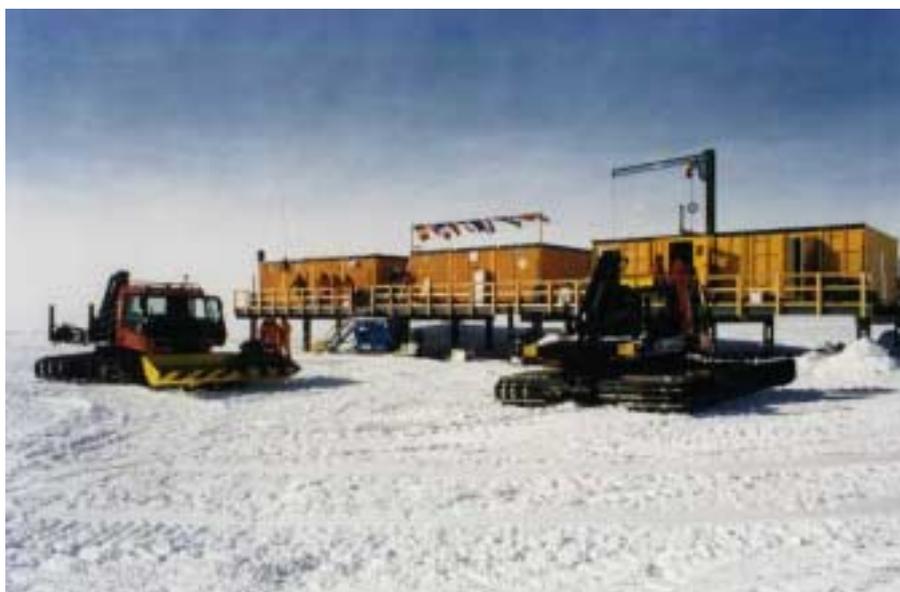
Photo 15: Infrastructure at the EPICA DML05 Drilling Site

The site also contains several small buildings for summer use, including buildings used for living quarters during the overland traverses.
