# Antarctic Treaty Inspections Programme Report 2014-15

Report of the Antarctic Treaty Inspections undertaken  
jointly by the United Kingdom and the Czech Republic in  
accordance with Article VII of the Antarctic Treaty and  
Article 14 of the Environmental Protocol

May 2015

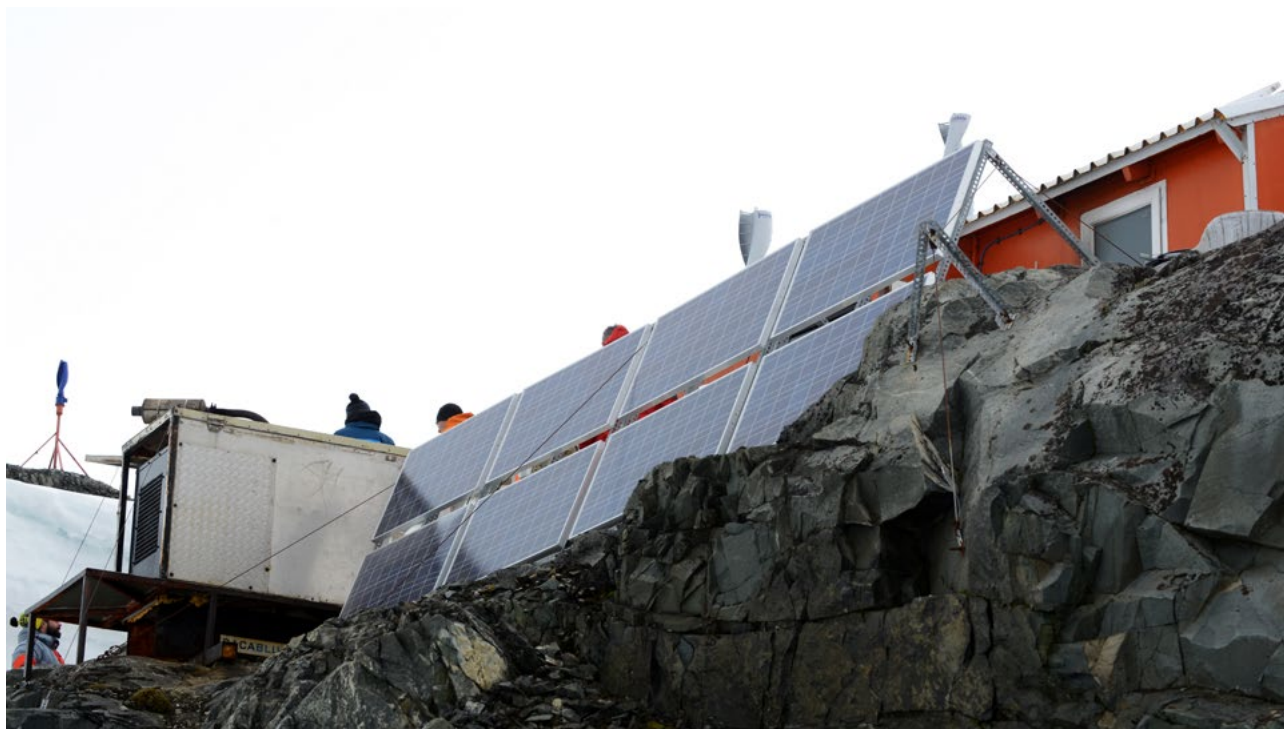
Fuel was supplied at the start of the season from Argentina, Chile or Brazil and was held in 205lt drums, or tanks and cylinders for diesel, petrol and propane respectively. Only small quantities, enough for one summer season, tended to be held, with diesel storage being no more than 5m<sup>3</sup> for an annual usage of approx 3.5m<sup>3</sup>. The bulk of the diesel was stored in drums on the beach, where there are plans to use a shipping container as a storage facility plus workshop in 2015. The remainder of the diesel, together with petrol, was stored directly adjacent to the main hut. Propane was stored separately, but also adjacent to the main hut.

Water for the station was provided directly from a nearby glacier melt lake via a pipeline to the main hut and accommodation. Ohridski was able to store 4m<sup>3</sup> in one large tank, additional small containers of 0.5m<sup>3</sup> were also stored in bathrooms.

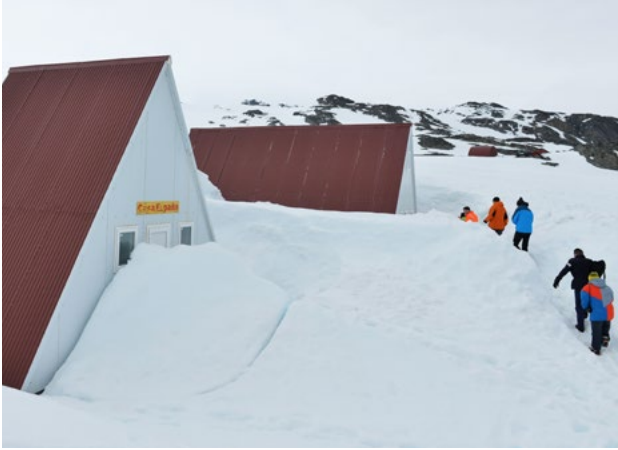
Ohridski is a small scientific research station operated by volunteers. The Observers were impressed by the use of renewable energy systems, including wind generators, PV panels and solar water heater on the station. They noted that major improvements had been made to disposal of sewage and grey water, with the installation of a small anaerobic sewage plant, since the last inspection in 2005.

However, the Inspection team considered that safety issues should be addressed as a priority at Ohridski: fire extinguishers were not prominently displayed, there was poor storage of flammable chemicals, irregular maintenance of the incinerator, and fuel handling and storage was not in line with current best practice, with evidence of numerous historic minor oil spills in the fuel storage area near the main building.

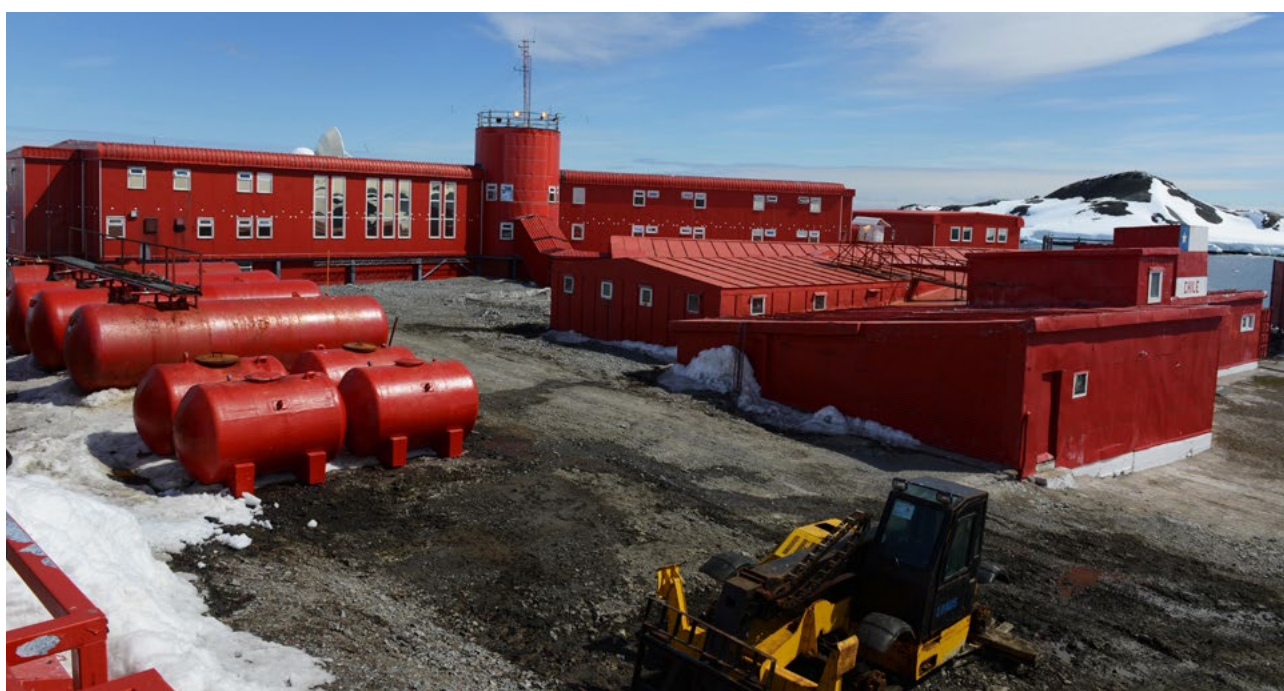
Diesel for the two 250kw Deutz generators was pumped directly from the storage tanks, and petrol for boats transferred using a hand pump. There were also a large number of 1000lt plastic

containers located adjacent to the main fuel storage facility which were partly filled with old fuel and sludge. Although there were no records of a fuel spillage having taken place at this facility in the last three years available for inspection, fuel management and spill response did not appear to conform with the best practice available, with only a very basic and minimal amount of spill response equipment on site. The Observers were told that the main oil spill kit would arrive with the resupply ship, which used floating hoses to resupply the tanks.

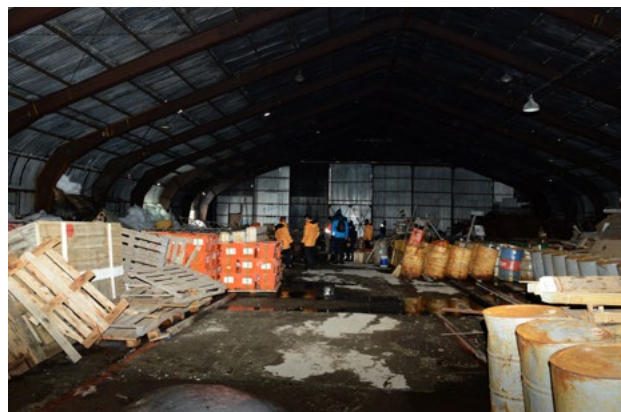
Whilst there was a considerable amount of snow and ice in the entrance way to the main hangar and some other areas, the building itself was generally sound. It was apparent that in some of the buildings, especially the medium-sized garage/warehouse, that plastic-framed windows had been installed relatively recently. However, most buildings were in a seriously dilapidated condition.

A set of historic fuel tanks was located to the east of the southern set of buildings. These appeared to be empty, and were intact and with no visible signs of leakage of fuel sludge either on the tanks or the ground beneath.

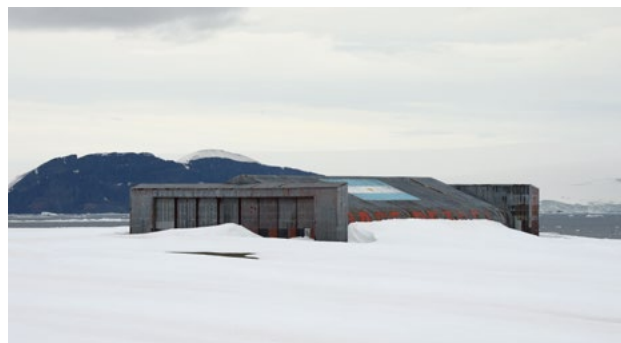
Bottled fresh water was used for drinking and all other water was currently being provided by melting glacier ice in the galley. An electric snow melter was in the process of being re-commissioned to be used to support this season's team.

The station was supplied by one Dietz 6 cylinder diesel generator producing 380v, 50hz with a capacity of 31kva which was fitted in 2012. A 200lt ready use tank housed in the generator compartment was refilled by 205lt drums kept beside the compartment and regularly re-supplied by ship. A small but effective spill kit was kept alongside the generator.

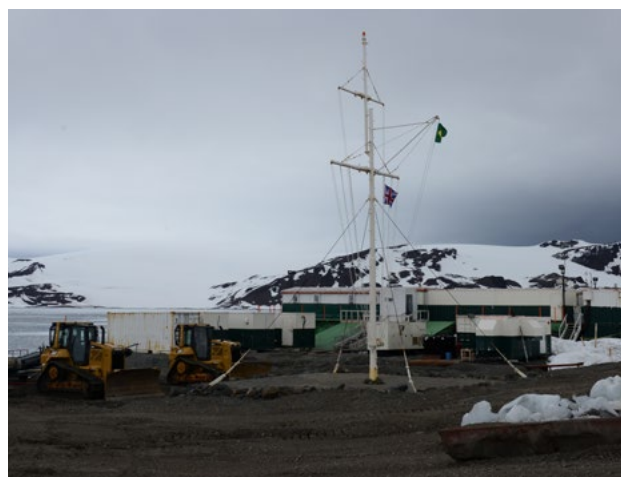
The accommodation and office spaces were separated into 17 zones for fire detection and controlled in the centre passageway. Portable 90kg compressed water extinguishers were situated along the passageway and north and south exits. Also, smoke curtains were used to break up the large accommodation spaces. Automatic fire suppression systems were in operation in the kitchen.

There were two fire emergency muster points in the facility with 20 breathing apparatus systems and fire suit sets. Fire extinguishers were returned to Brazil at the end of each season and recharged units brought in. Whole-station fire training took place every week.

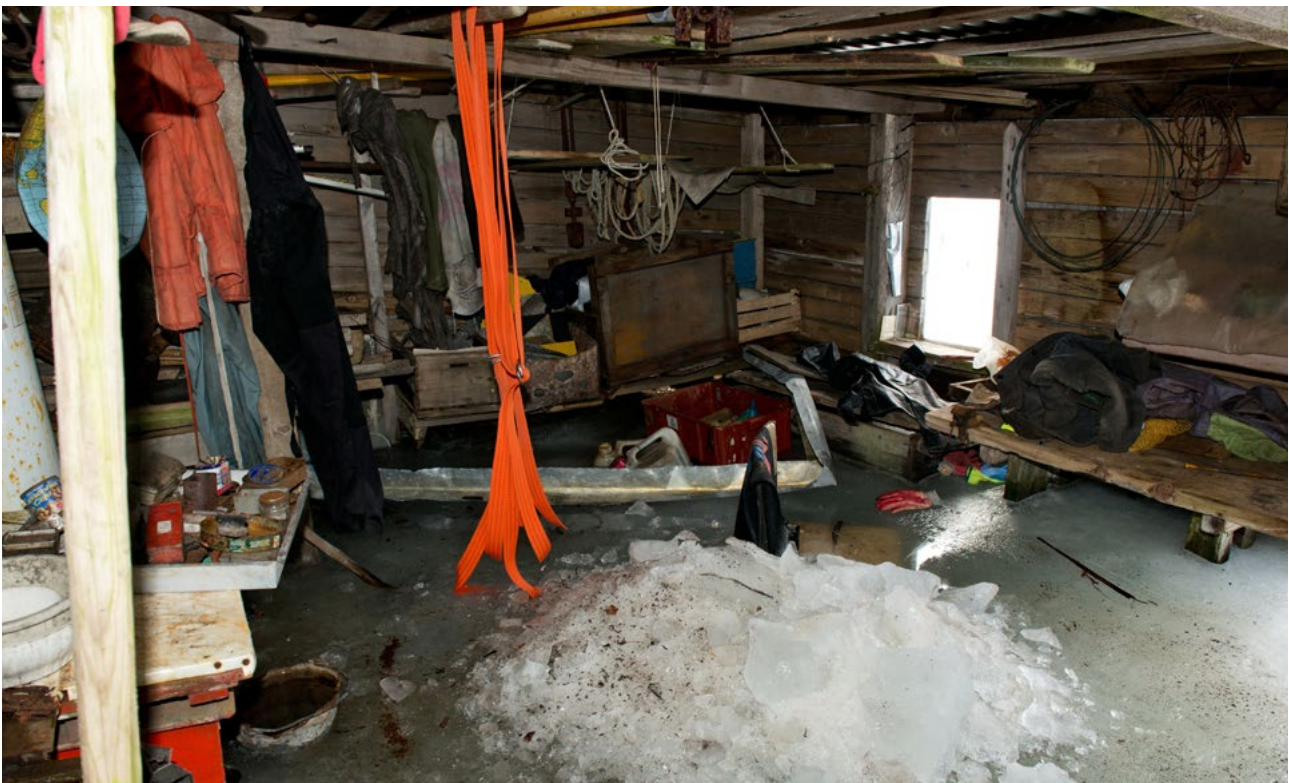
The huts at Eco-Nelson had always been minimalistic and rudimentary, although judging by pictures shown to the Observers by the occupier, the facility was clearly once in much better order. The huts were now in an extremely poor state and there was no evidence of any significant recent repairs or ongoing maintenance. The largest room in the main hut had at least 30cm of solid ice on the floor, indicating a lengthy period of neglect. It was the strong opinion of the Observers that the facility posed a significant safety risk, not least fire but also of collapse.

The Observers were told by the occupier that Eco-Nelson had been occupied year-round in the past, and that he was hoping to secure another winter resident this season. It was the opinion of the Observers that such a solo over-wintering would be not only very dangerous, but also impossible in the living conditions they found.

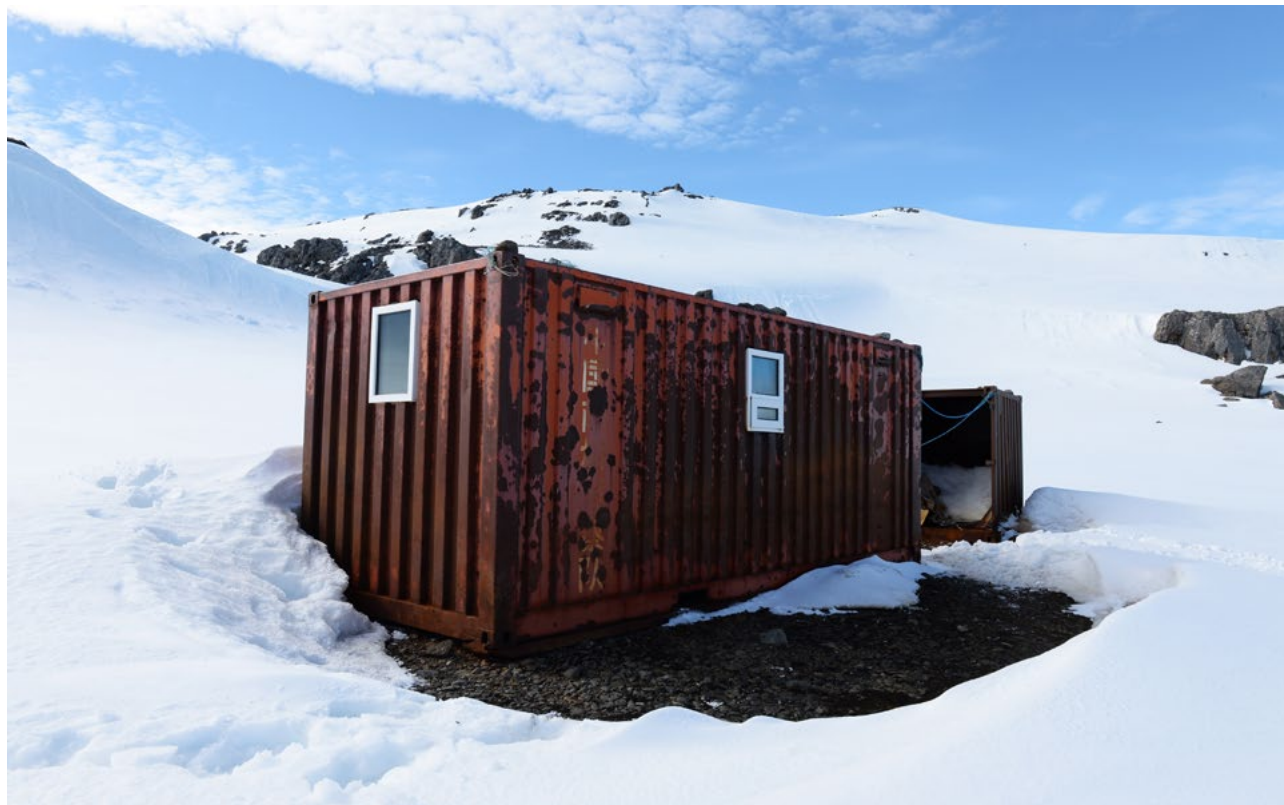
# Stansbury Peninsula Refuge (China)

Whilst approaching Eco-Nelson (a non-governmental Czech facility) the Observers identified a small refuge approximately 1km to the east of that facility, around a small headland and situated approximately 20m above a gravel and rock beach.

rusting and exterior deterioration. A large, apparently empty, rusting gas cylinder was being used to hold the door closed.

The refuge on the Stansbury Peninsula was built by China in 1987 for emergency situations for Chinese scientists carrying out field work in glaciology and geology. It has been not used for many years. China has been planning to remove the refuge whilst considering the transport capacity. It expects it will be done in two years. China will be fully aware of the impact on the local environment when it removes the refuge and will do its best to minimise any impact.
