# Australian Antarctic Treaty Inspections

December 2016

Amundsen-Scott South Pole Station (United States)

Report of Inspections under Article VII of the Antarctic Treaty and Article 14 of the Protocol on Environment Protection to the Antarctic Treaty

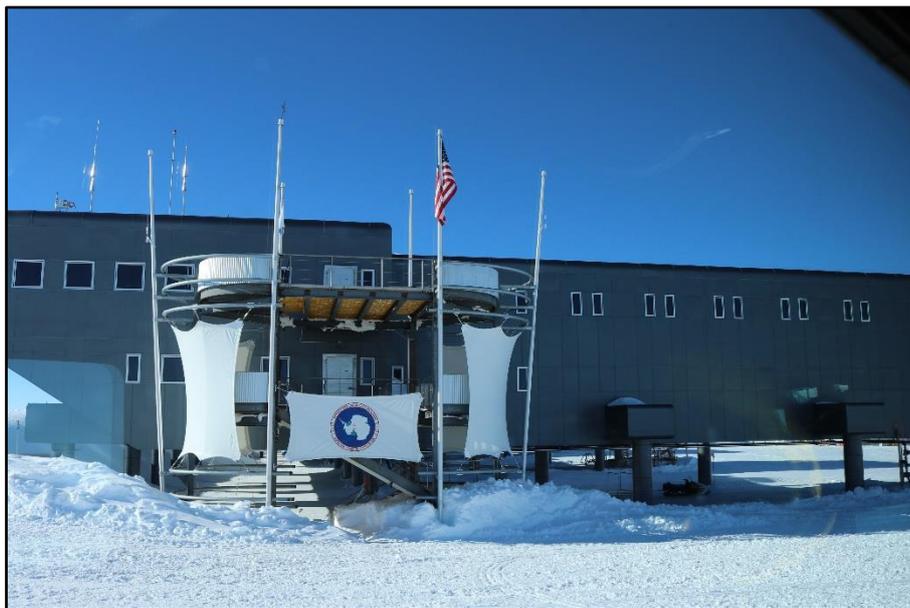
*Amundsen-Scott South Pole Station main station building (photo: Katrina Cooper)*

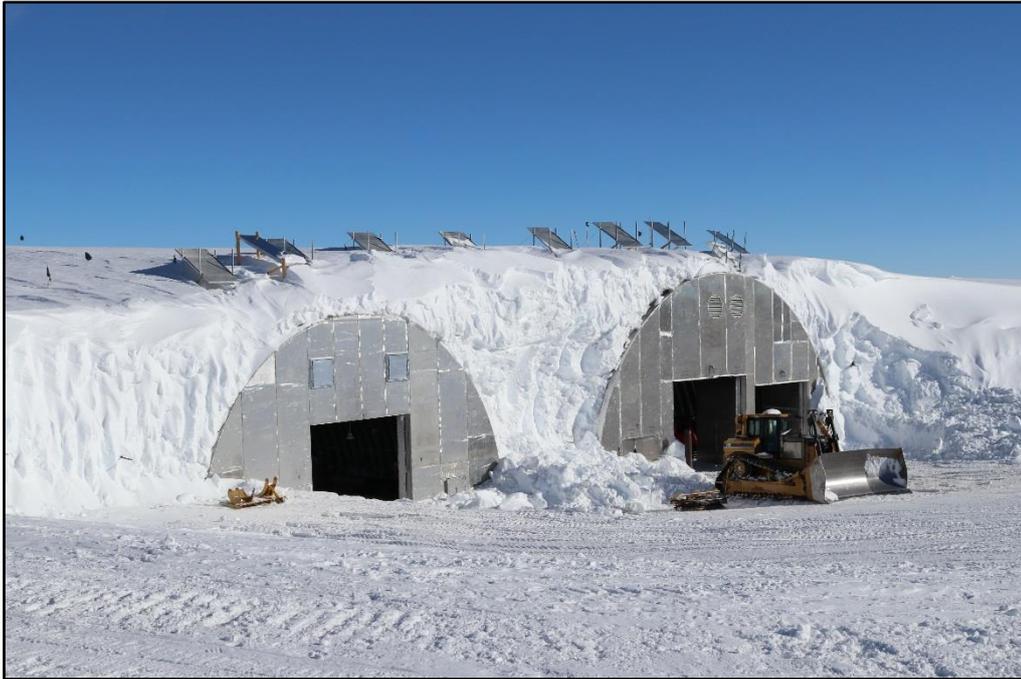
*Under-ice network (photo: Katrina Cooper)*

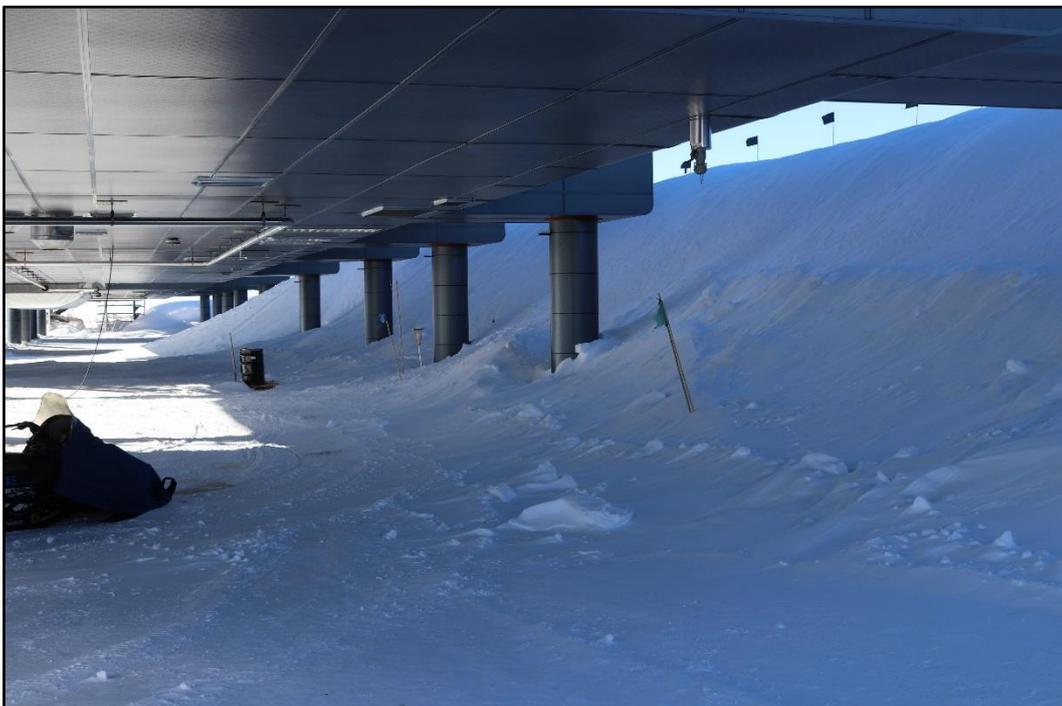
The station is orientated to be orthogonal to the prevailing wind direction, and utilises that wind to minimise snow accumulation below the structure. The main building is built on a series of columns embedded into the firn and is designed to allow for the entire structure to be raised the equivalent to two stories (6 m) in the future. It has not been necessary to raise the building so far, but some minor height adjustments to individual parts of the building have been necessary to allow for different settling rates across the building.

*Columns beneath the main Station buildings (photo: Katrina Cooper)*

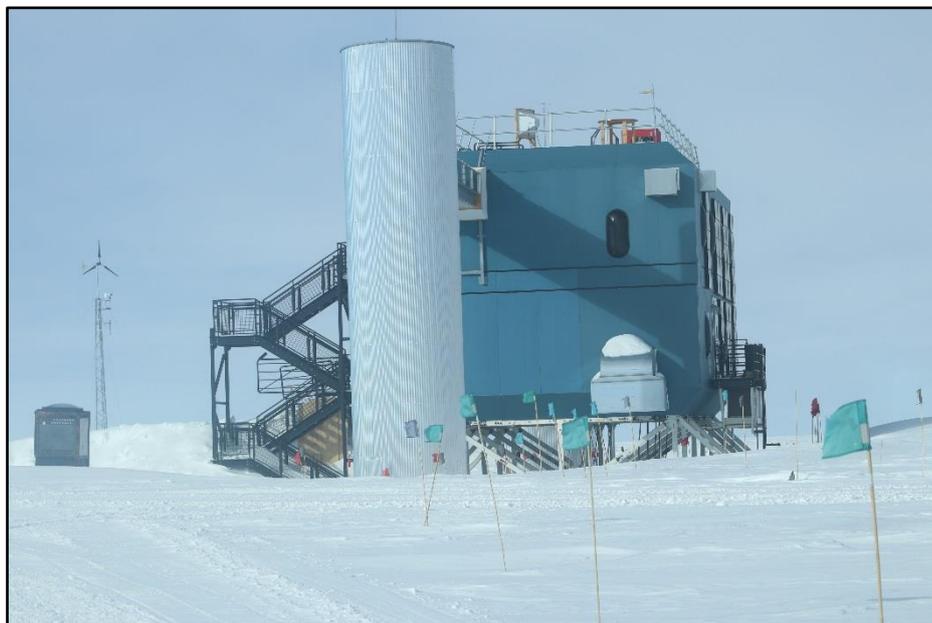
*IceCube Neutrino Observatory (photo: Katrina Cooper)*

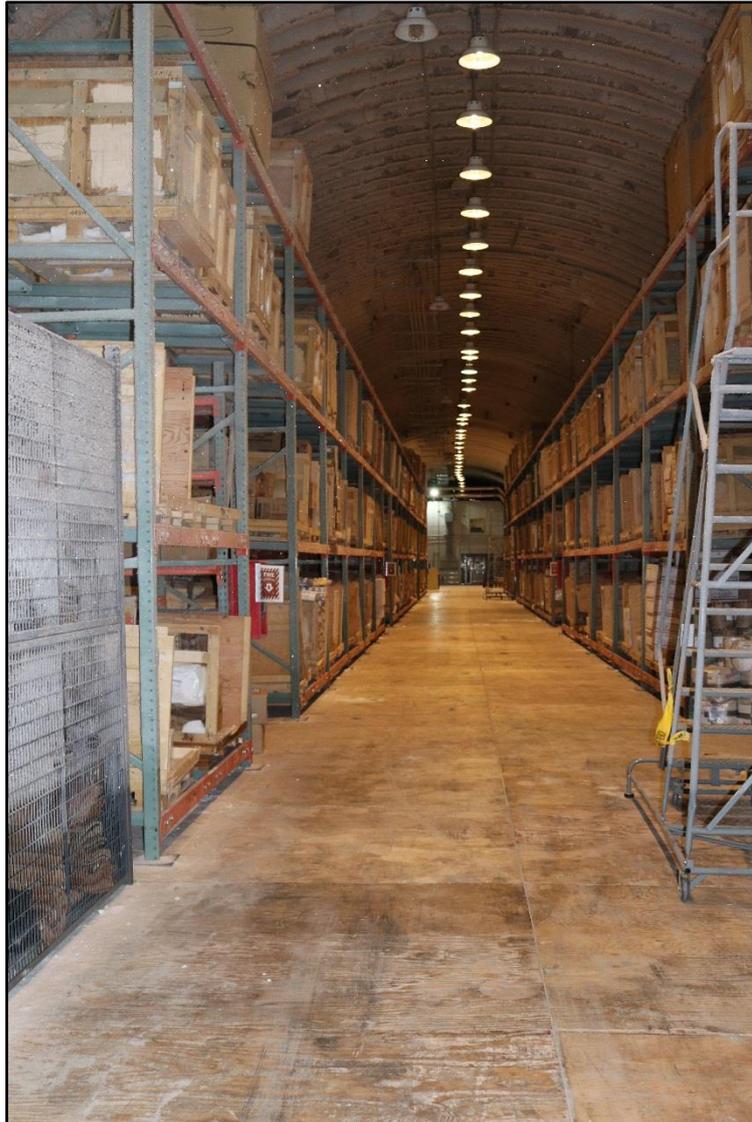
While there are warehousing facilities both below the ice and through the main station building there are some evident pressures in managing the very high volumes of material needed to sustain the station. This is a common pressure at Antarctic stations and is being well managed at the South Pole through the use of external ice berms to allow for storage outside while protecting from snow accumulation. The relatively low snow fall and wind strengths mean this approach is highly effective. The network of berms appeared well organised and managed.

*Storage facilities on Station (photo: Katrina Cooper)*

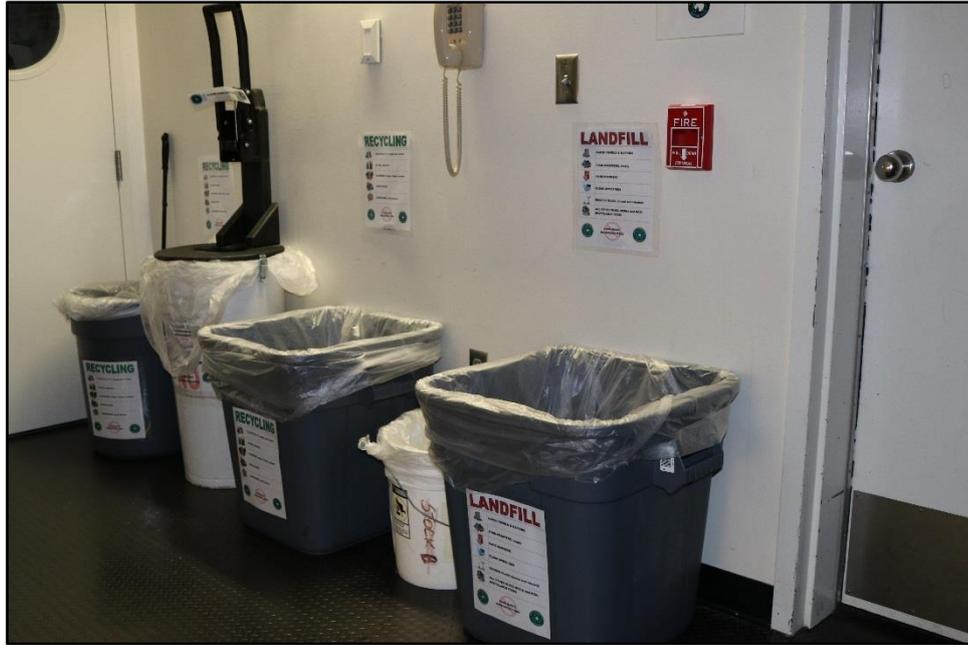
There is strong evidence of recycling of waste embedded in the station culture. Systems for separation of waste are evident throughout the station with plentiful, well-marked bins provided for recyclables and landfill for return to the United States. There is also prominent and frequent signage reminding personnel on station of their obligations to separate waste. In the galley, kitchen waste is also separated from other forms of waste.

*Waste sorting on Station (photo: Katrina Cooper)*

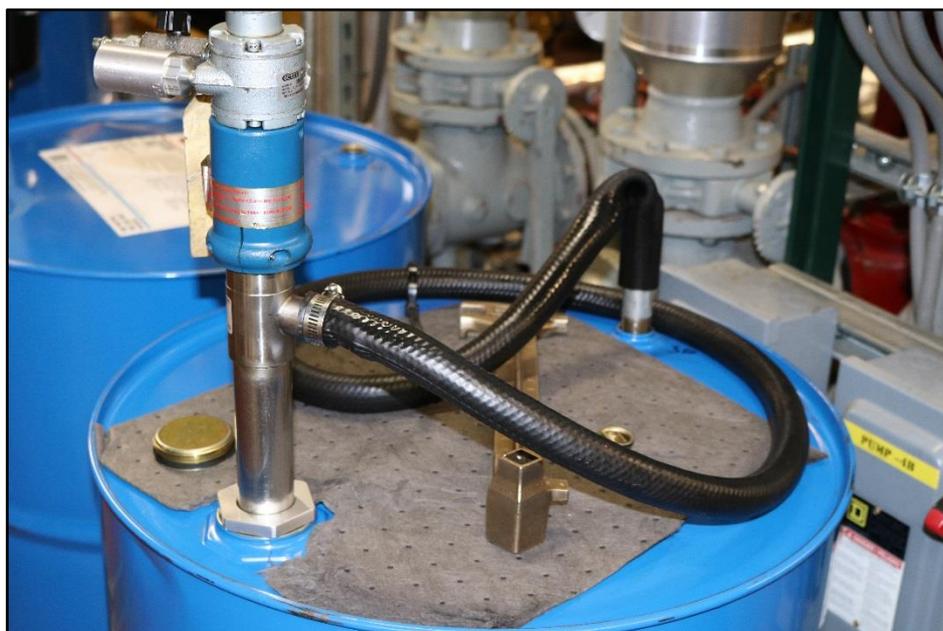
Particular note was taken of aircraft refuelling procedures. The inspection team observed the infrastructure established for refuelling which was designed in a way which minimised the risk of spillage. There is ample evidence of good practice to deal with accidental spillage including the placement of absorbent mats on top of fuel drums.

*Fuel spill mats used on drums (photo: Katrina Cooper)*

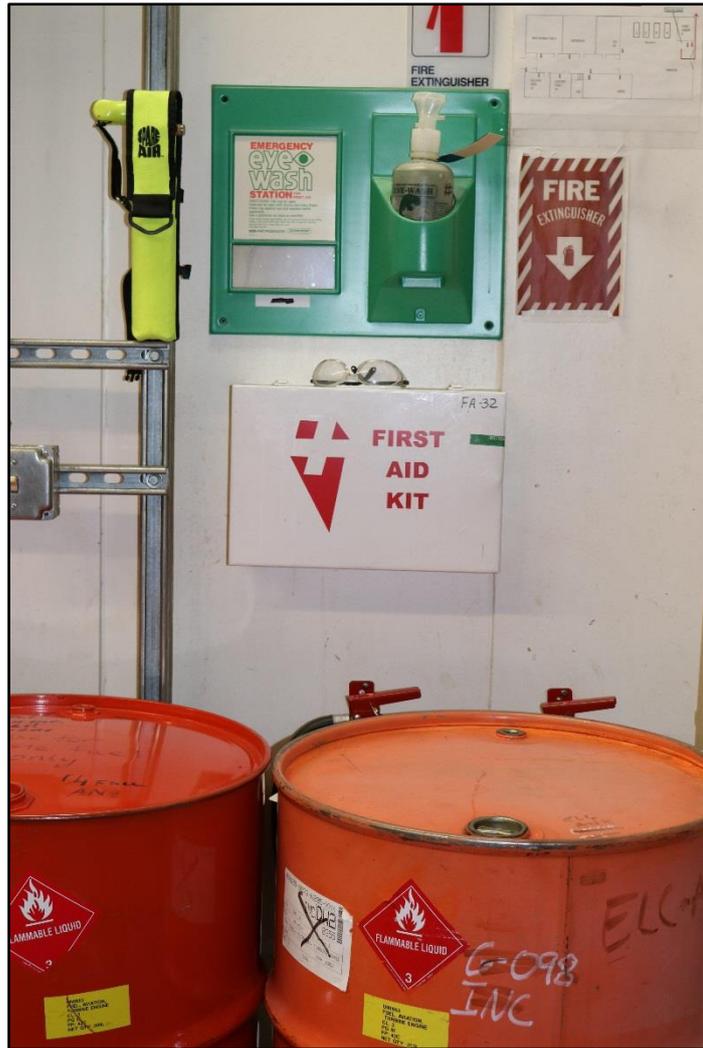
Fire hydrants and muster points were observed throughout the station. Rescue equipment was observed in a number of locations. The inspection team was informed of the existence of specially trained emergency response teams – particularly for fire. While the induction video did not cover the various alarms, this may be covered in the more extensive briefing provided to station personnel.

*Safety equipment evident on station (photo: Katrina Cooper)*

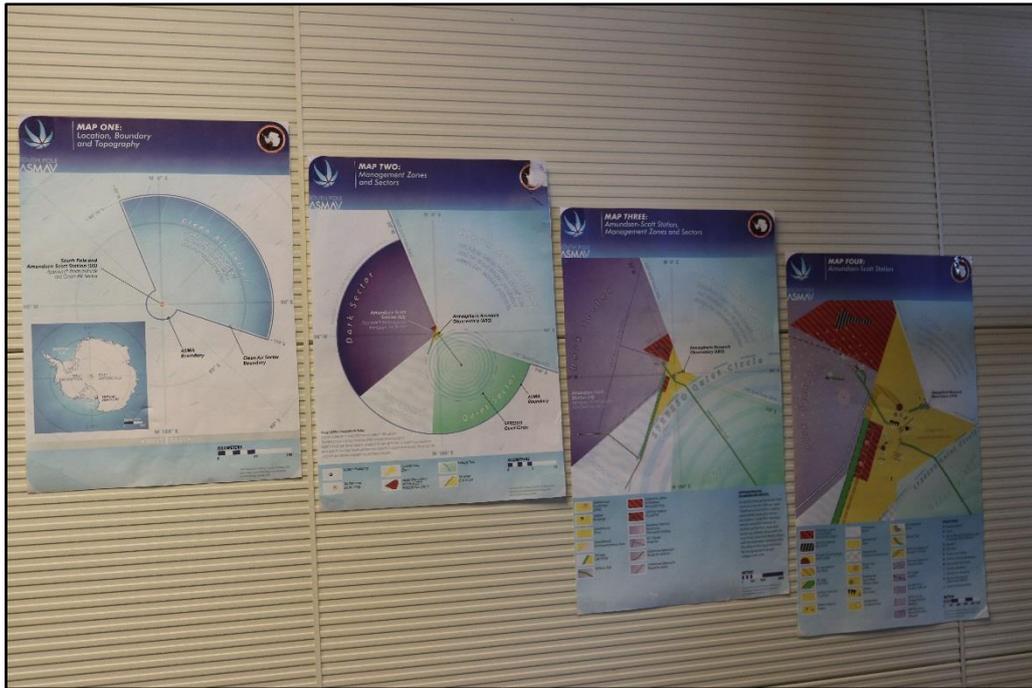
The immediate environs of the station are divided into sectors representing the various zones, including the Operational Zone, Scientific Zone, Historic Zone and Hazardous Zone. The Scientific Zone is further split into the quiet sector, dark sector, downwind sector, clean air sector and South Pole Remote Earth Science and Seismological Observatory (SPRESSO) quiet circle. The management arrangements are operationally complex but appear to be well understood and managed by station personnel. Although the absence of defining landscape features or boundary markers meant that the boundaries of the zones / sectors were not immediately apparent to the inspection team, the allowable travel routes are clearly marked and there appears to be a high degree of understanding among station staff about the various management areas and the requirements thereof.

ASMA maps available on display for station personnel (photo: Katrina Cooper)

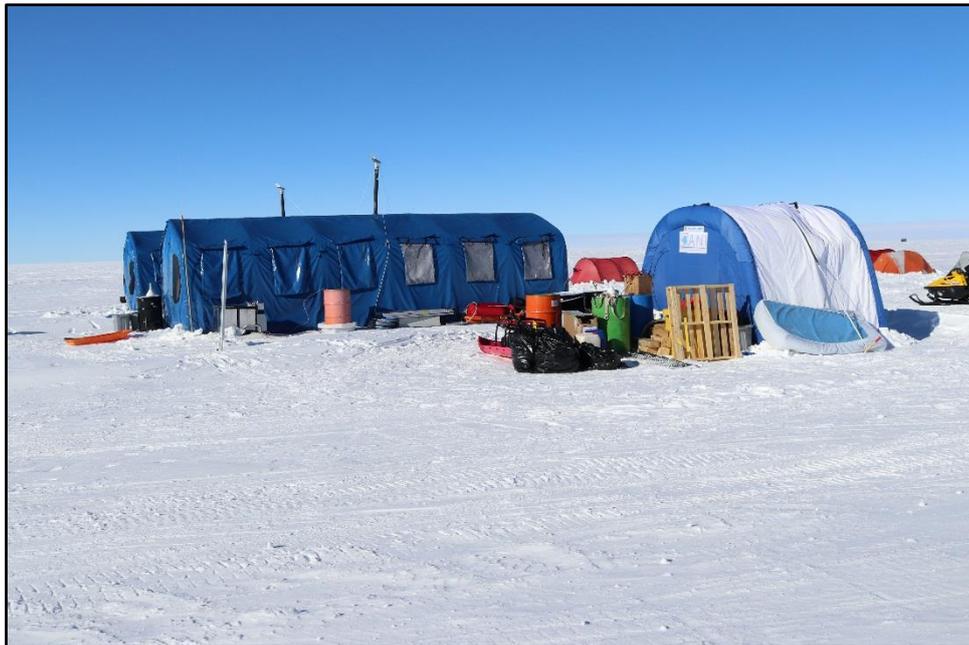
The inspection team also briefly visited the Antarctic Logistics and Expeditions (ALE) campsite, located within the designated NGO camping area approximately one kilometre from the station, and spoke to the site manager. At the time of the visit the ALE camp was the only NGO operator presence at South Pole, with other operators conducting fly-in-fly-out operations. The camp was in good order and it was apparent that there was a good relationship between the station and ALE. The site manager briefed the inspection team on ALE environmental practices in the ASMA and explained that, with the exception of grey water, all rubbish, including human waste, generated in the ASMA was returned to the United States via ALE's camp at Union Glacier. Grey water was disposed of with the assistance of the station. The inspection team was given details of ALE's environmental policies and noted that the site manager was clearly aware of and complying with the ASMA management plan. The inspection team noted the good relationship between the ALE camp and the station, including having clear processes for interactions between the two parties.

*ALE Campsite (photo: Katrina Cooper)*
