**Report of the Joint Inspections Program
undertaken by Argentina and Chile under
Article VII of the Antarctic Treaty and
Article 14 of the Environmental Protocol**

4. Inspection Report Palmer (United States)

5.1 Introduction

7.1 Introduction

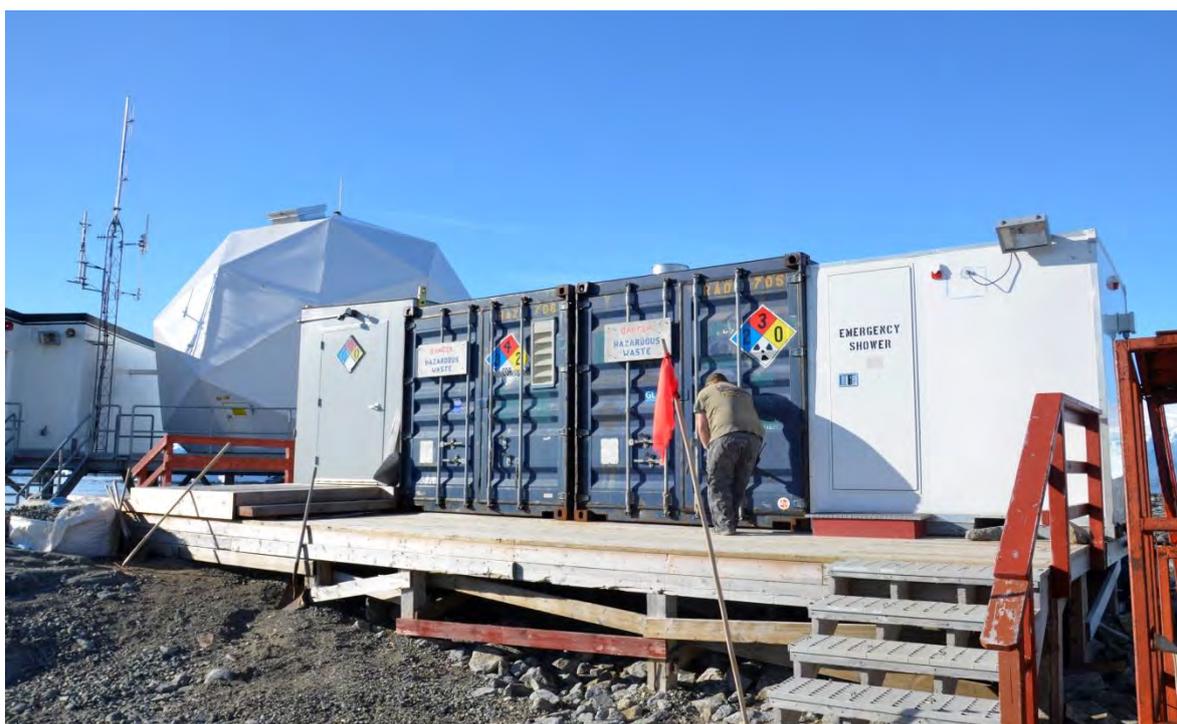
Palmer has a specially prepared container to process and categorize all hazardous wastes produced at the station. In addition, chemical wastes generated on board US Antarctic research vessels are temporarily stored at the station. Used batteries, radioactive materials, fuel and lubricant residues with high levels of heavy metals, as well as chemically treated wood and paint are mainly shipped off the station.

Figure 9 – A specially assigned sector, separated from other buildings for storage of hazardous chemical products in adapted containers that include chemical shower in case of spill or accidents.

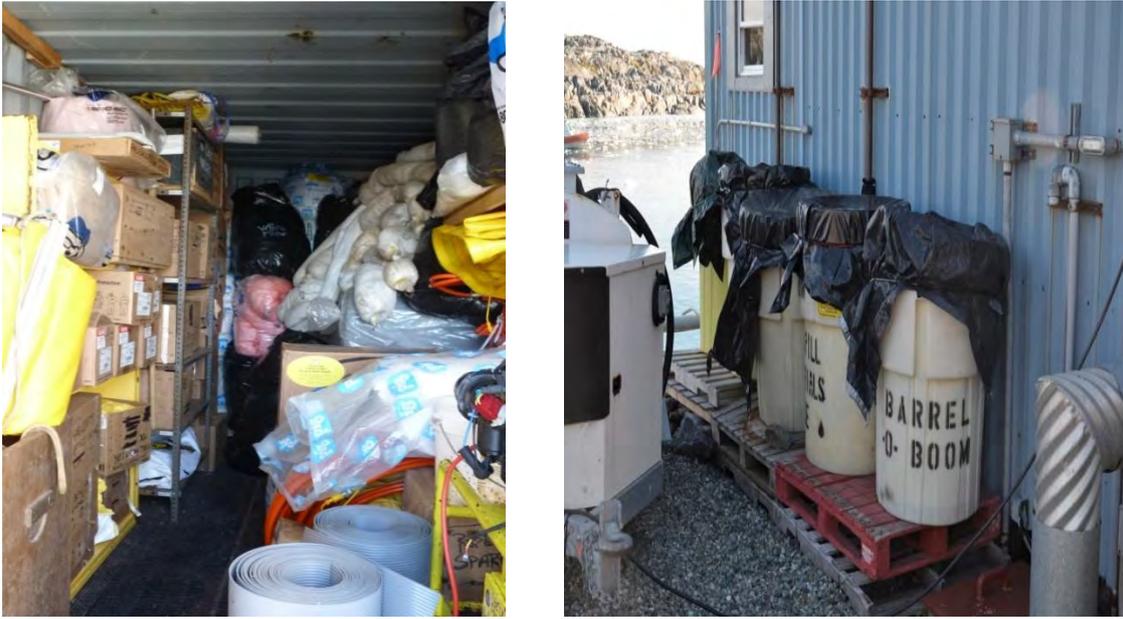
In different sectors of the station, barriers and appropriate products have been prepared for oil spill mitigation, while containment materials for larger spills is stored separately, both on land and at sea. The hydrocarbons spill prevention equipment includes plastic containers with built-in spill containment for transport and storage of 205-liter fuel drums, which provide a greater margin of safety.

Figure 10 - Container for storage of different oil spill mitigation materials (left). Anti-spill materials available at different points of the station. (right)

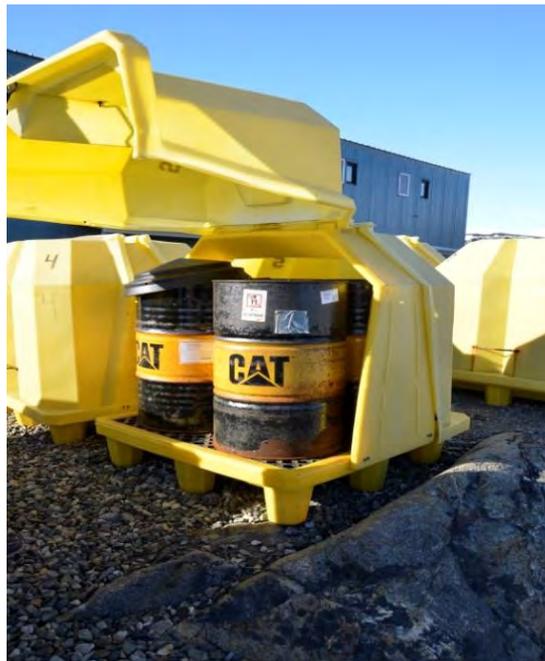
Figure 11 – Plastic Containers for storage and transport of fuel barrels.

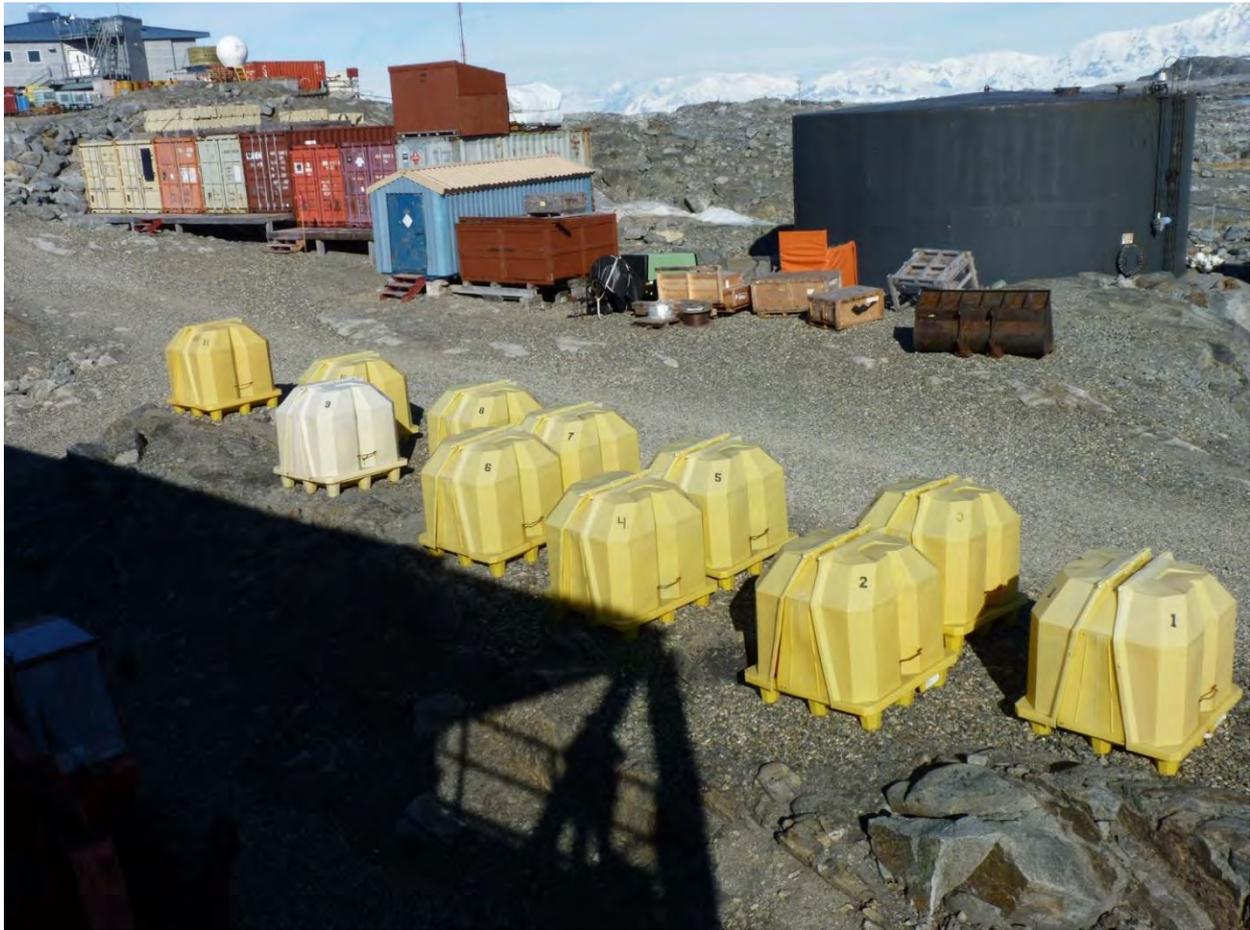
Figure 12 - Fuel drums storage area, in protective containers with built-in anti-spill containment, to prevent accidental spills

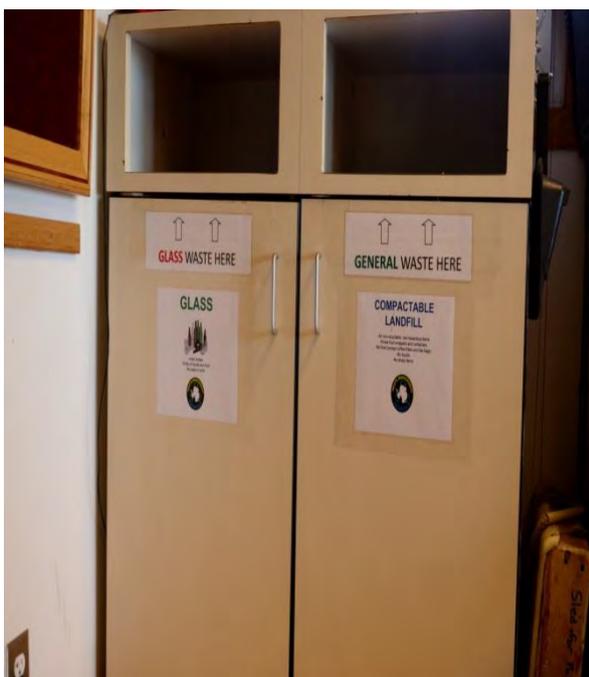
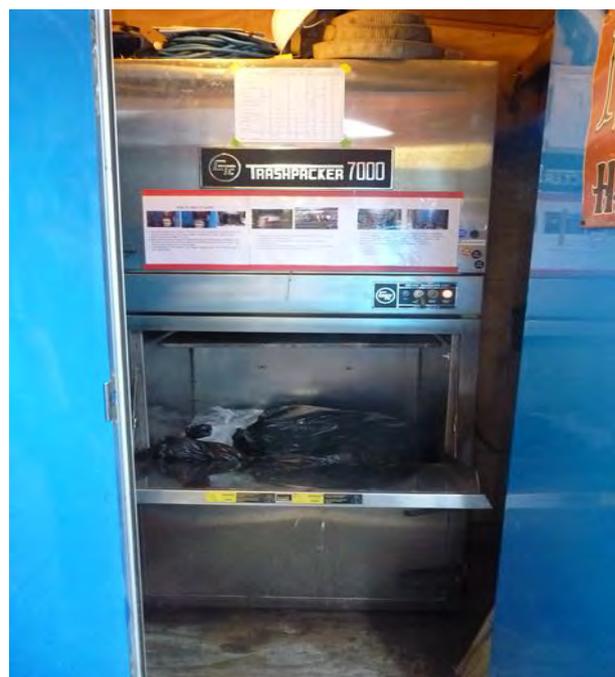
Based on the information provided to the inspection team, all non-hazardous wastes are sorted at the source according to the categories used in Punta Arenas, Chile (city of final disposal). Containers for different wastes are placed in different areas of the station.

Figure 13 - Example of waste storage area (A), which facilitates sorting and subsequent treatment of certain types of wastes in a compactor (B).

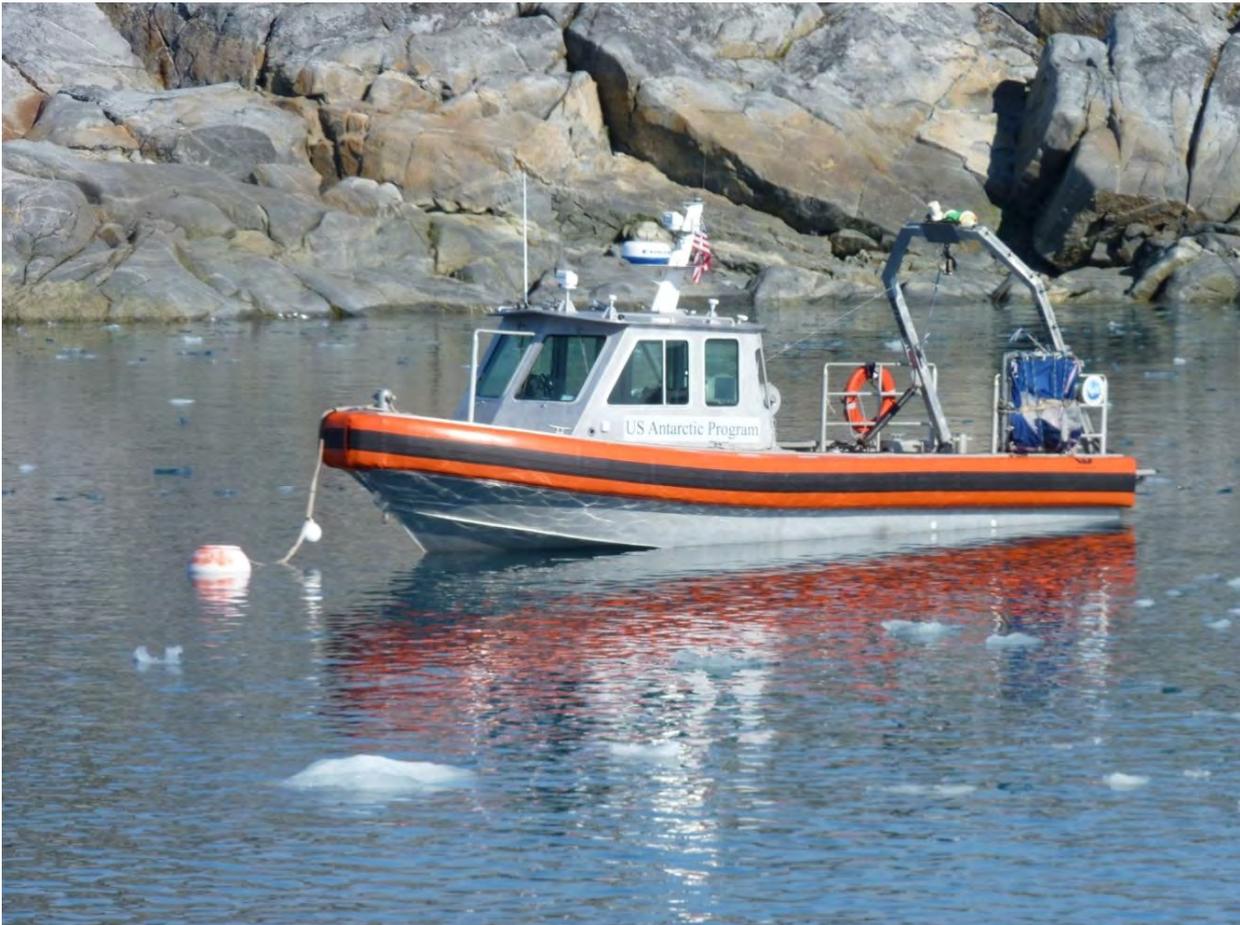
The station has two off-road vehicles of the ATV type and two snowmobiles. It also has eight Zodiac-type boats, three of which are available for immediate use, one of them a 7.6 m long with two outboard motors, two 5m semi-rigid inflatable aluminum cabin-less vessels. (RHIB) and two cabin boats, 10 m long with built-in engine.

Figure 14 - Aluminum-cabin marine boat with interior motors.

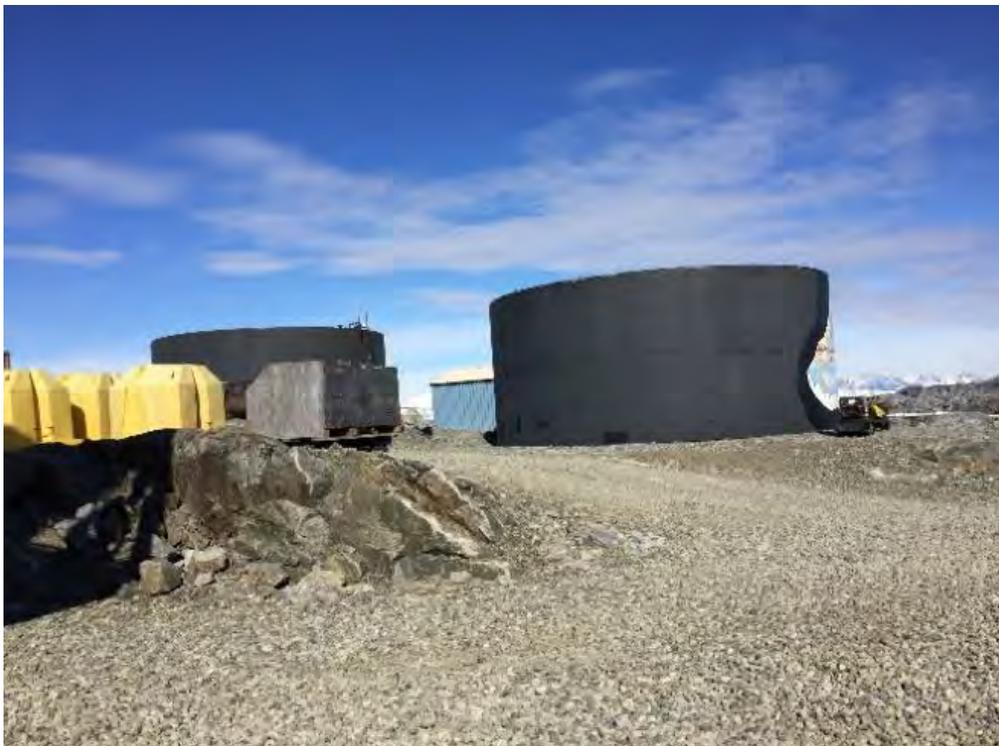
Figure 16 - Diesel fuel tanks

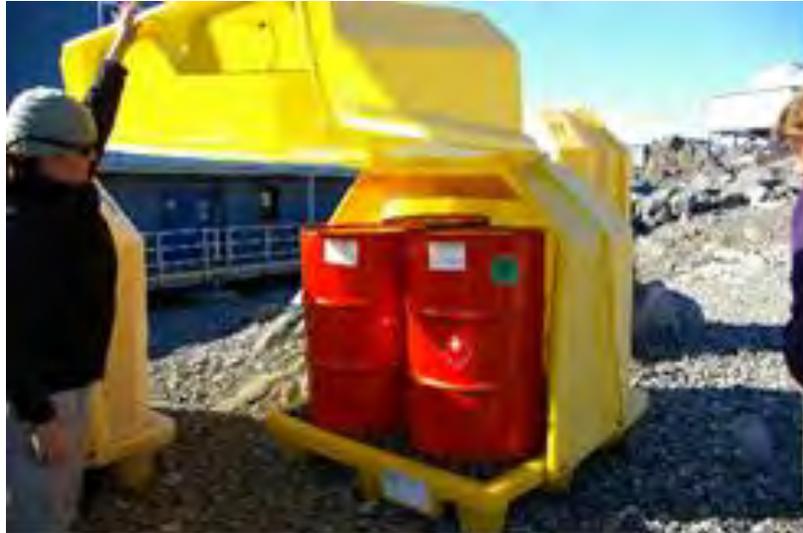
The supply of fuel and its transfer to different tanks is maintained under permanent visual observation of lines, valves and tanks. Twice a year, fuel is supplied from the "ARSV Laurence M. Gould" vessel to the station's two main tanks. For the storage of 200-liter drums with gasoline, there is a system of plastic containers with a capacity of four drums that allow to contain any type of spill that is generated in its

handling. The inspectors observed that this type of storage measures and methods is a very good and effective practice to avoid spills in the transfer of these liquids. This method is very convenient to store, classify and handle 200 liter-drums, apart from being very safe, could be an example for other stations and relatively easy to implement.

Figure 17 - 200 liter drum anti-spill storage system.

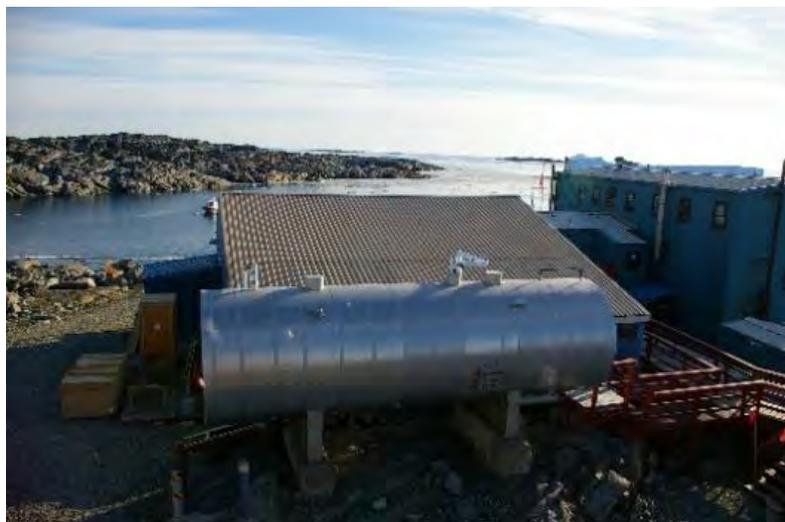
The station has a fuel distribution system through 10 and 5-centimeter steel pipes connecting the main tanks to those used daily. These are both above and below surface, which increases the visibility and control of spills or leaks. The transfer of fuel is made with electric pumps, which maintains the control and monitoring of these maneuvers.

Figure 18 - Diesel fuel tank for daily use.

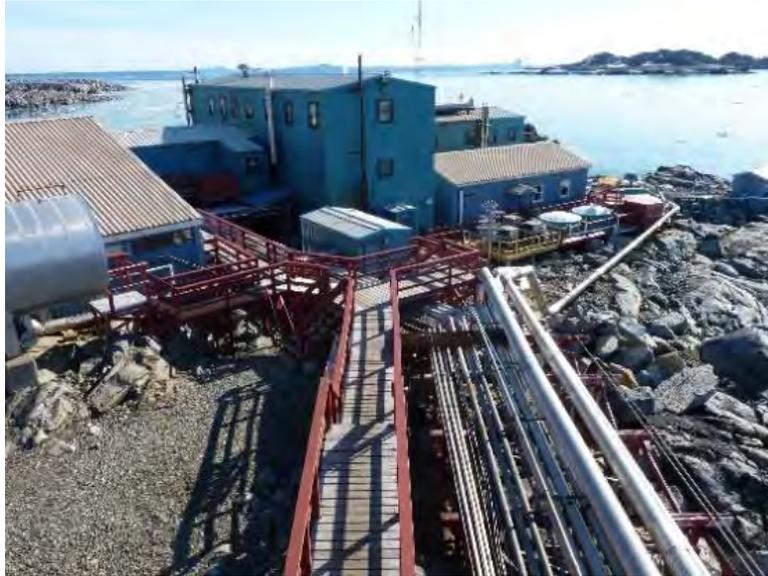
The fuel supply from the ship to the station is done by mooring to the dock through a 10-cm pipe and an overall length of 46 meters to the tank. The ship's electric pumps transfer the fuel. The pipes are cleared by gravity and air compressors. The station carries fuel operation and handling manuals. The inspectors were informed that operating manuals and standards are available in the station's management office.

Figure 19 - Supply line of pipes and cables between the different premises.

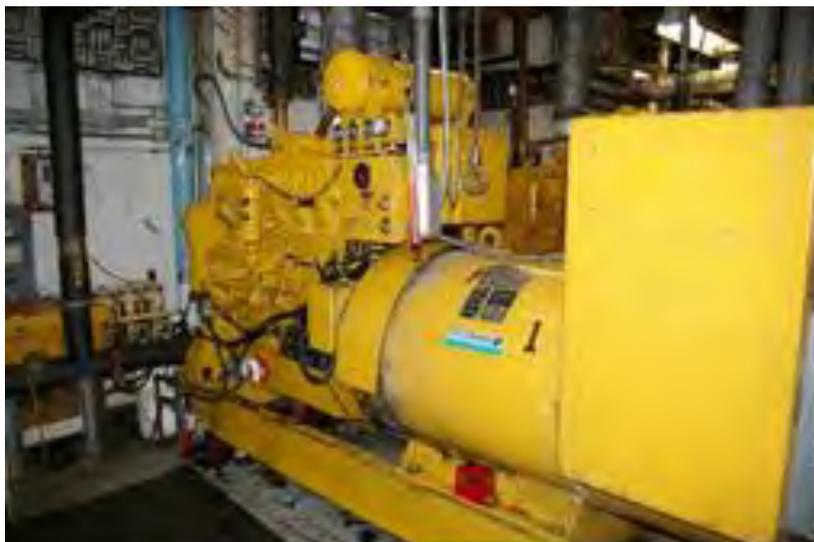
Figure 20 - 250 kW engine power generator facility

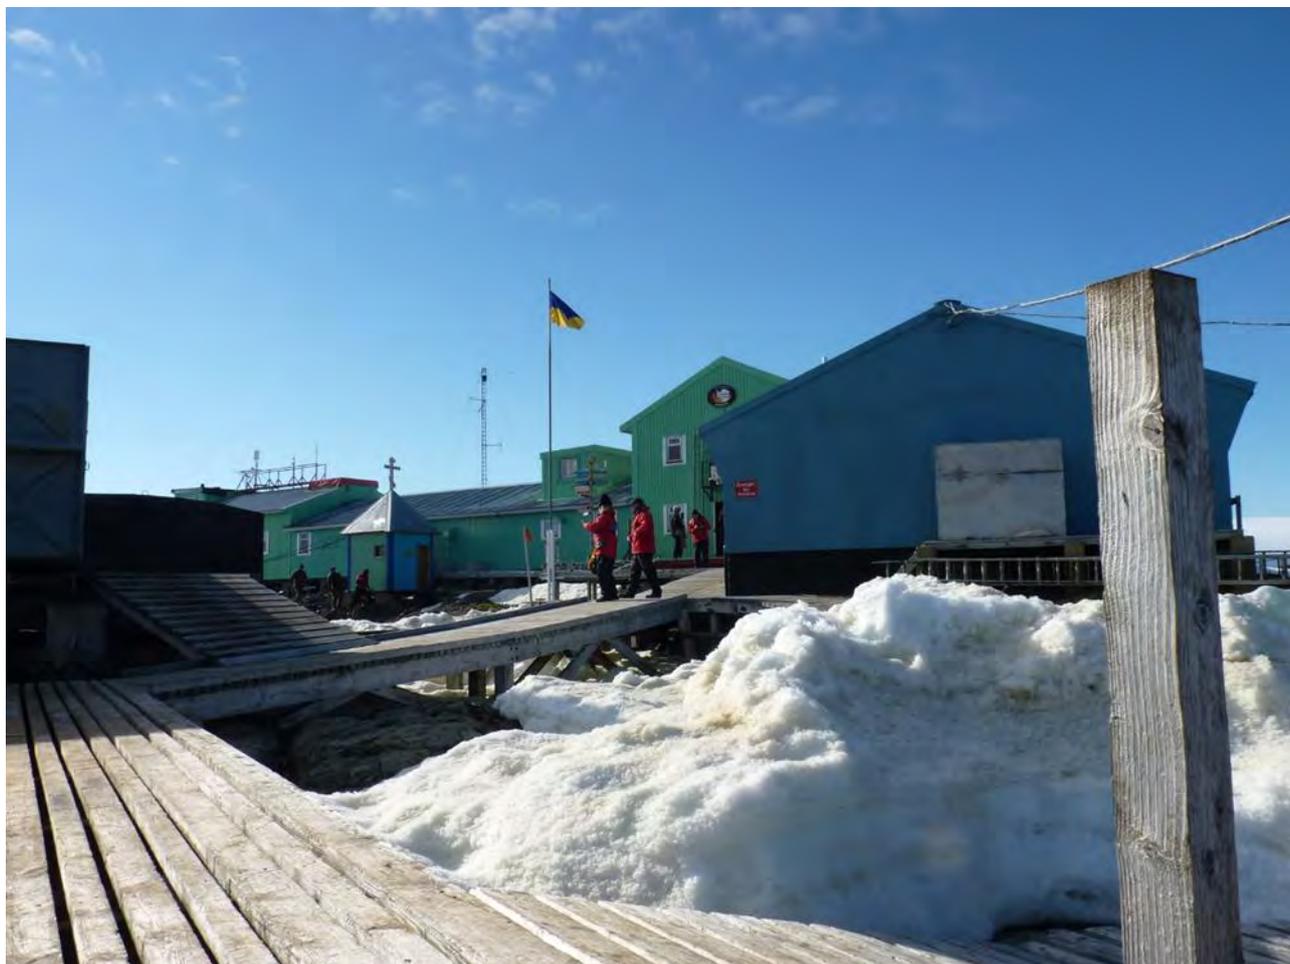
Figure 21 – View of main buildings and chapel

In general terms, it is a station with significant science activity -especially earth sciences-. From the point of view of the facilities, the inspectors could observe some signs of deterioration and obsolescence.

The general appearance of the buildings is good, although it is inevitable to note that they are relatively antique structures, taking into account that the station dates from 1953 with some extensions made in 1980. A wooden walkway links the main buildings, facilitating the movement of people and cargo.

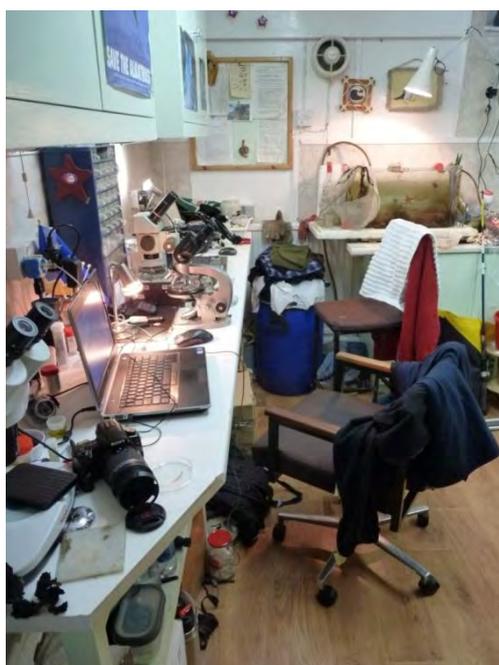
The biology laboratory consists of a small room where a group works in the study of benthic communities and pollution, parasites in fish, and microbiology of bacteria. This laboratory has an extraction hood for microbiology work. Monitoring of penguin colonies (information that is reported to the Commission for the Conservation of Antarctic Marine Living Resources, CCAMLR) and seal surveys are conducted at the biolab and, during 2019, long-term program for monitoring of whales, which includes studies on genetics and photographic identification. This work will be developed by the Ukrainian Antarctic Scientific Center, in cooperation with the University of California at Santa Cruz (USA). Due to the increase in activities in the area of biology, the researchers of the station consider it necessary to enlarge the laboratories. There is also a biology office, for the person in charge of birds and mammals census.

Figure 24 - Partial view of the biology laboratory

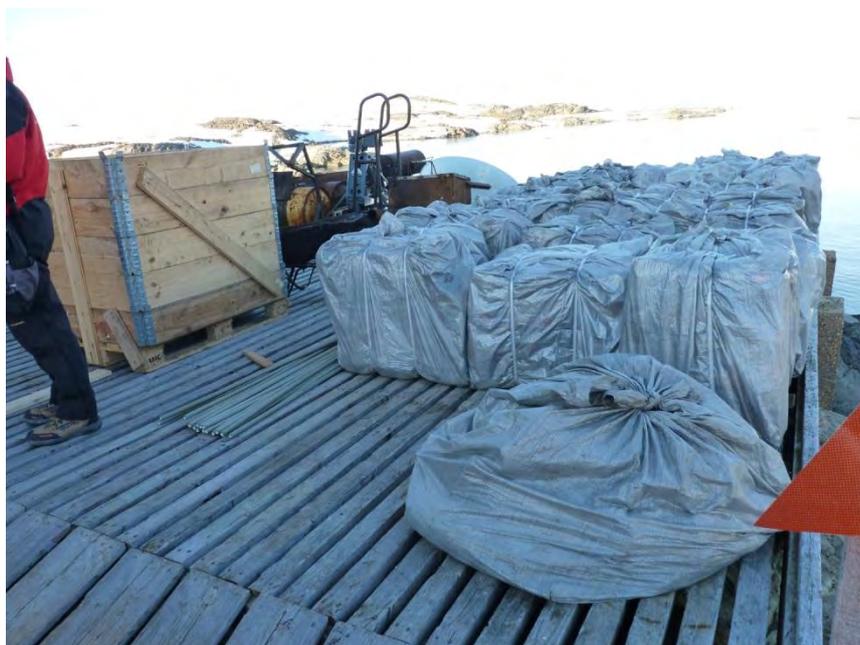
Figure 25 - Part of the waste stored on platforms surrounding the main buildings

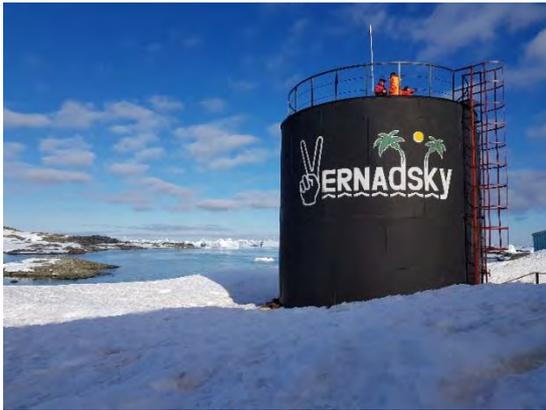
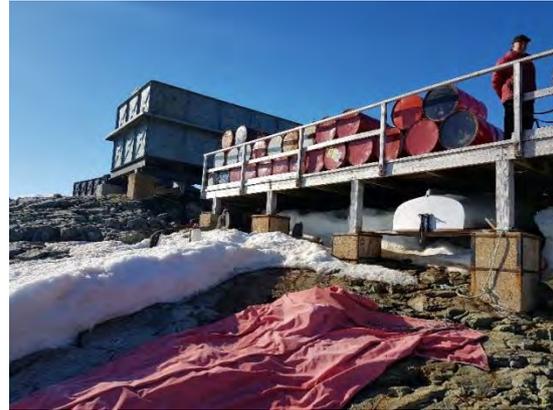
The station has a new fuel storage tank, in excellent condition, and an old alternative tank, which, according to staff, has been recently inspected and is ready for use in case of need for transfers. However, leaks were observed in some of the pipes.

Figure 26 - View of the main fuel storage tank and part of the 205 liter drums.

Likewise, gasoline and diesel are stored in 205 liter drums arranged outside the power plant building. Two 145 m³ and 33 m³ old tanks for storage of bulk fuel are kept in the original site, although they are no longer used for fuel storage. One of them was already conditioned as a deposit and in the short run the same would be done with the second tank already empty.

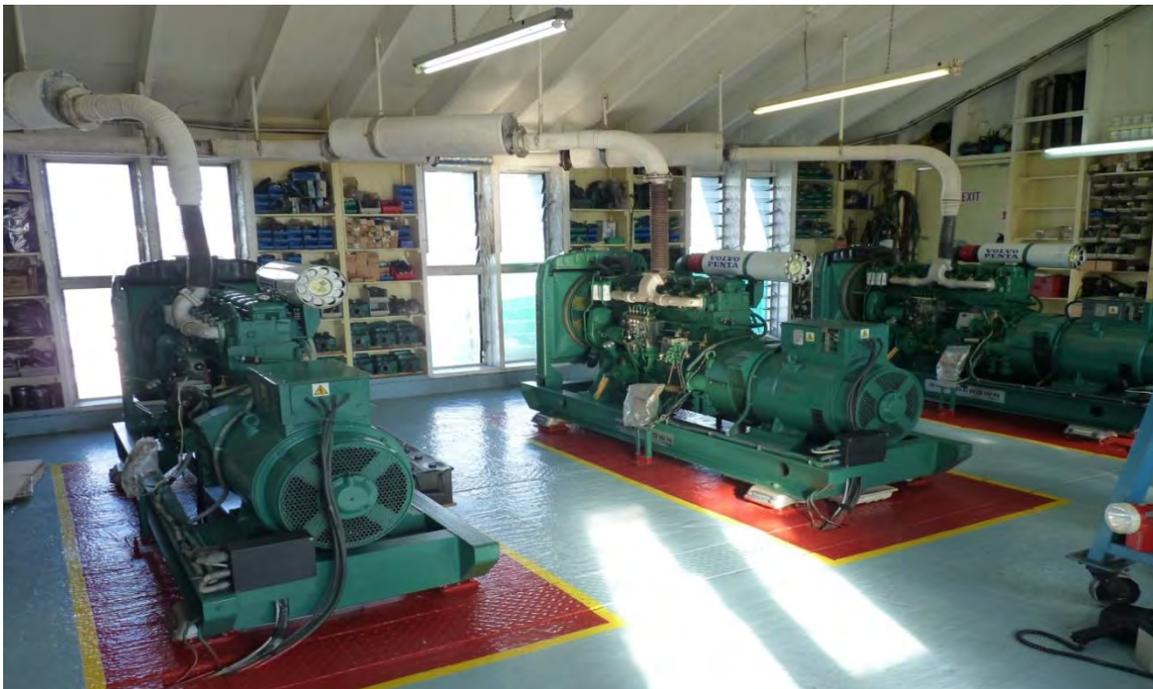
Figure 27 - Generator room

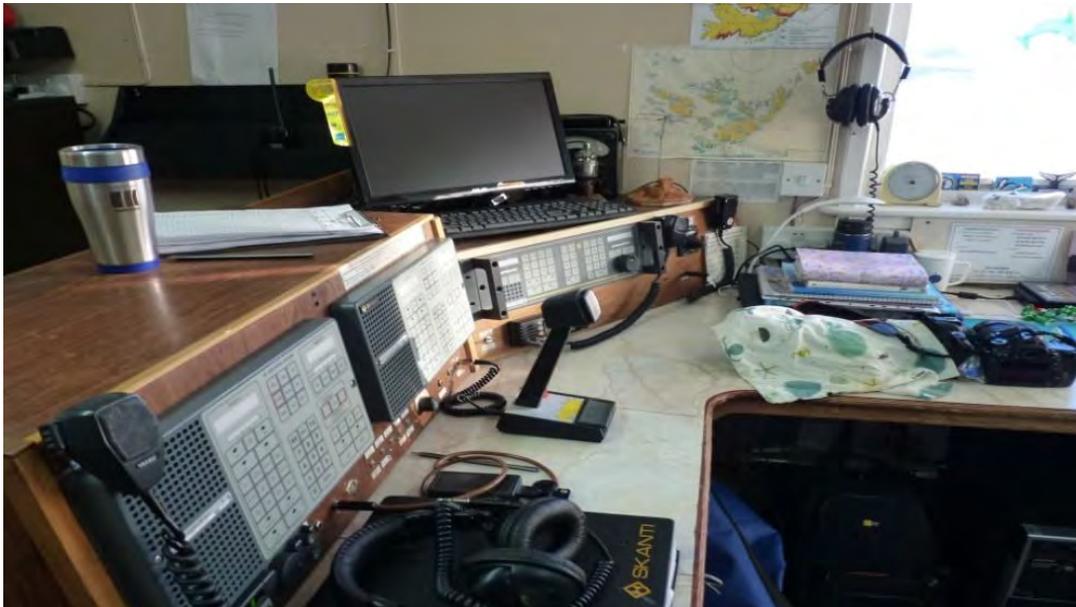
Regarding **communications**, the station has VHF and HF radio equipment, satellite telephony (Iridium) and internet (30 GB per month).

Figure 28 – Radio equipment

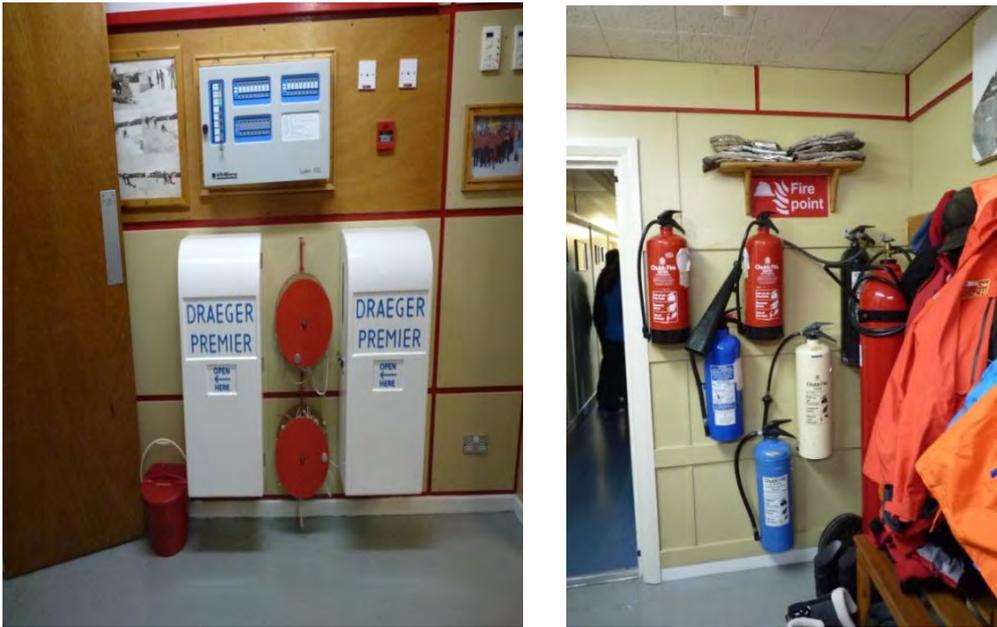
Figure 29 - Central Alarm and manual firefighting equipment arranged in the main building of the station

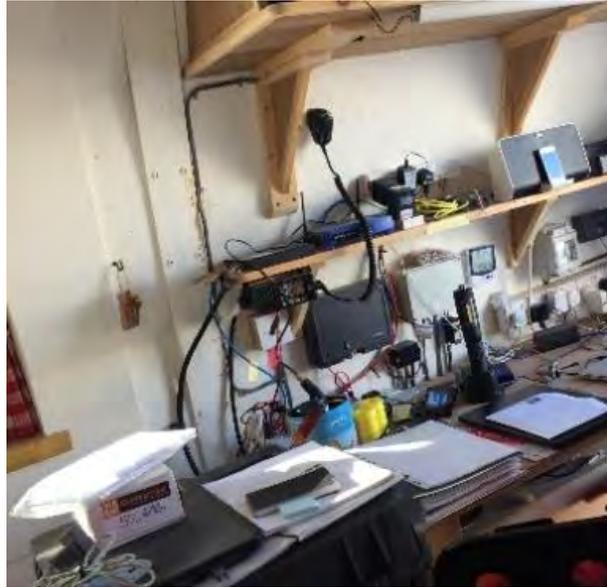
The station has a VHF radio for internal communications and for short-range maritime links. It has an Iridium satellite phone, with two more backup units, plus an HF radio that would only be used in case of emergency. It also has a satellite email system and a computer with SATphone connection with GPS location capability. It was noted that all communication elements are powered by solar panels. In case of failure of such system, there is the possibility of using one of the portable power generators. The telecommunications equipment is entirely kept at the “Nissen Hut”, with a backup set in the Boatshed for emergency use.

Figure 34 – Table with telecommunications equipment

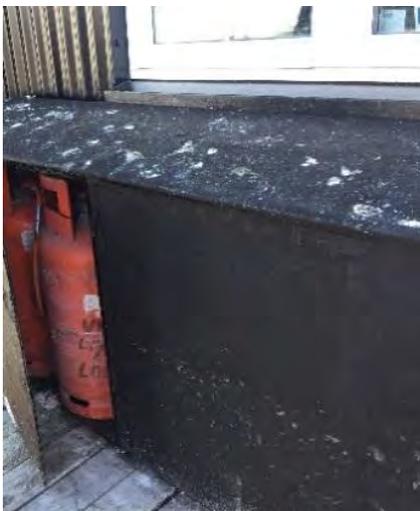
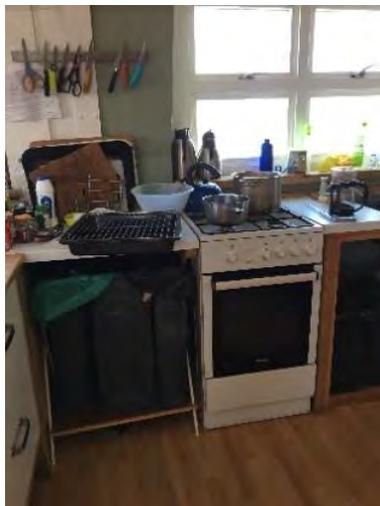
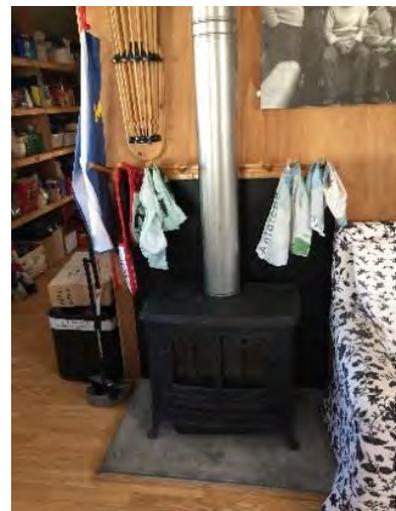
Figure 35 – Gas supply system for kitchen and heating.

There are five manual fire extinguishers distributed in the different buildings, with the Station Leader being responsible for the administration of fuel safety and management. No hazardous chemicals are used or kept at the station. In the main house, smoke detection system was observed.

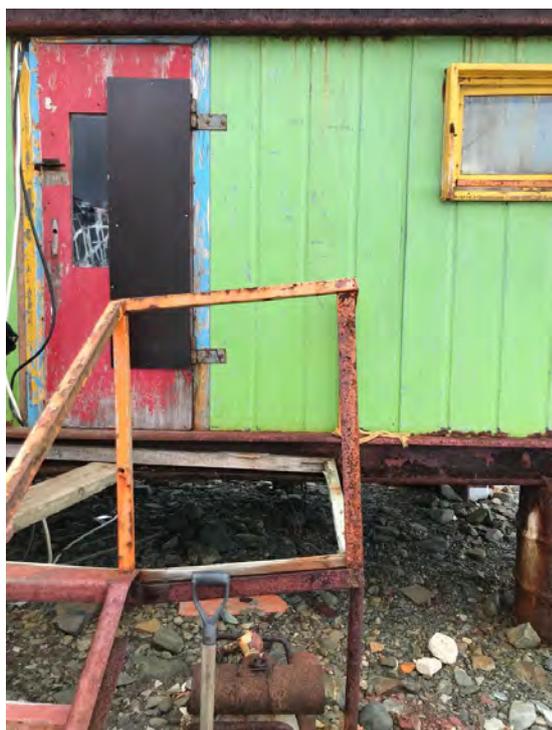
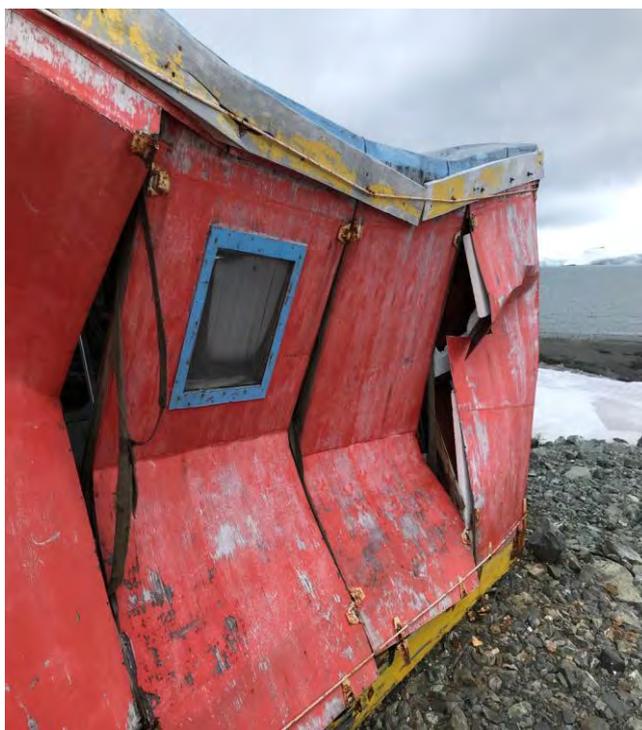
Figure 39 – Serious deterioration and damages to the first facilities

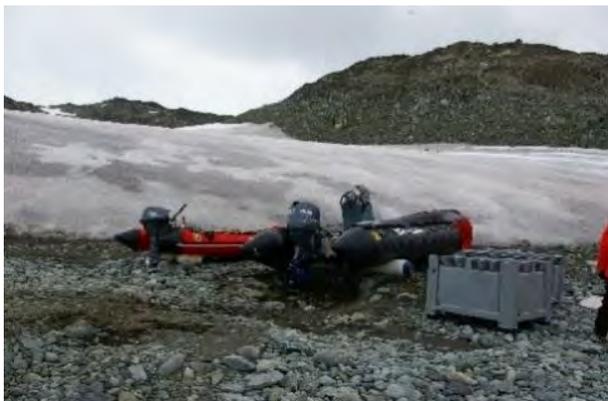
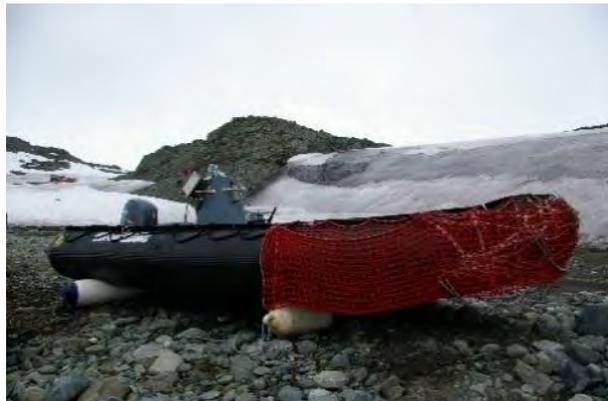
It has two snowmobile vehicles and two Zodiacs, which allow short sea trips in the area of the South Bay.

Figure 40 – Nautical means located on the beach of South Bay.

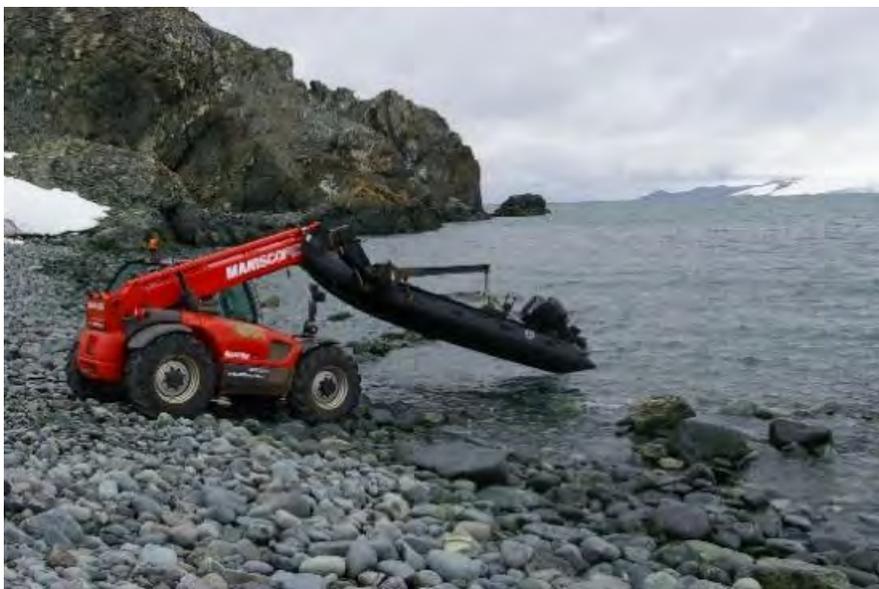
There is also a wheeled “Manitou crane”, which performs different tasks with great efficiency and flexibility in support of land and sea maneuvers.

Figure 41 – Operation with Manitou crane and Zodiac boat for inspectors redeployment.

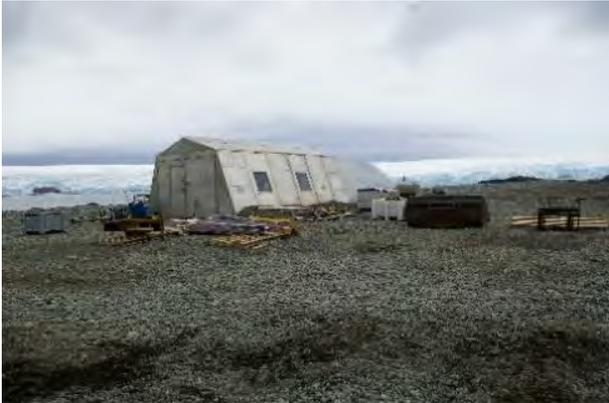
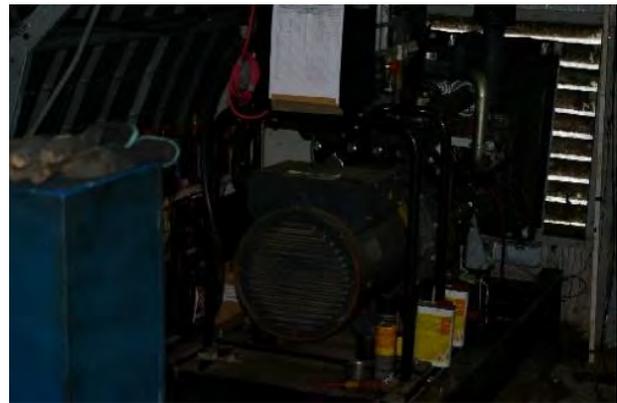
Figure 42 – Shelter on the beach with power generator inside.

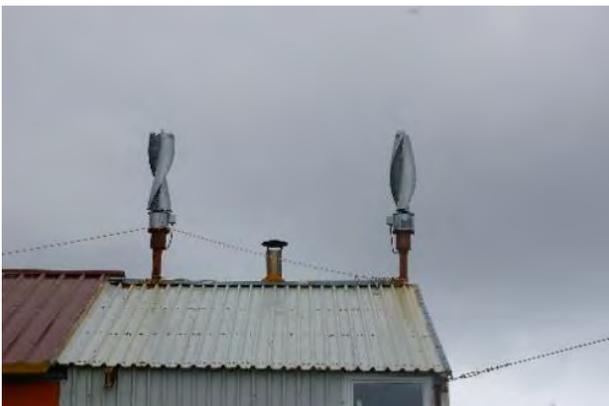
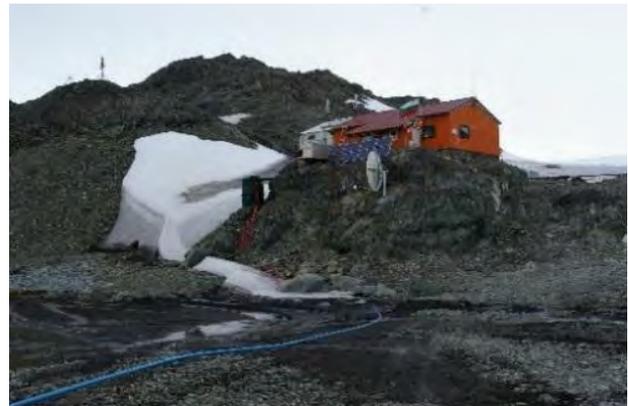
During the rest of the day the basic energy is supplied by a renewable energy systems, placed on the roofs of the rest rooms and main building. To this end, the station has small wind turbines for the generation of renewable energy that are complemented with power generation through solar panels, providing minimum electrical supply, enough for the operation of Internet during the day.

Figure 43 – Renewable energy generation system.

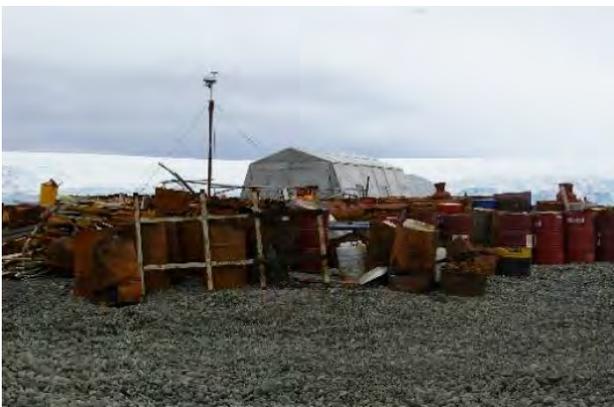
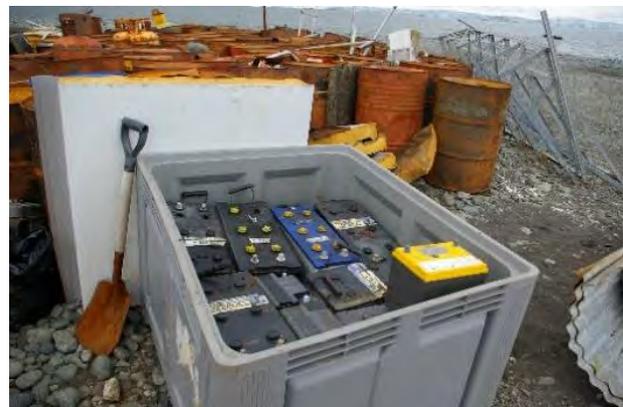
Waste material is also stored near the generator shelter, at the beach. Reportedly, removal should be done by sea. The inspectors noted that this activity should be prioritized and implemented through a short-term removal plan. In this way, a greater impact on the environment could be avoided, considering the high corrosion observed in the waste stored outdoors without any protection.

Figure 44 – Beach location for storing waste material and fuel drums

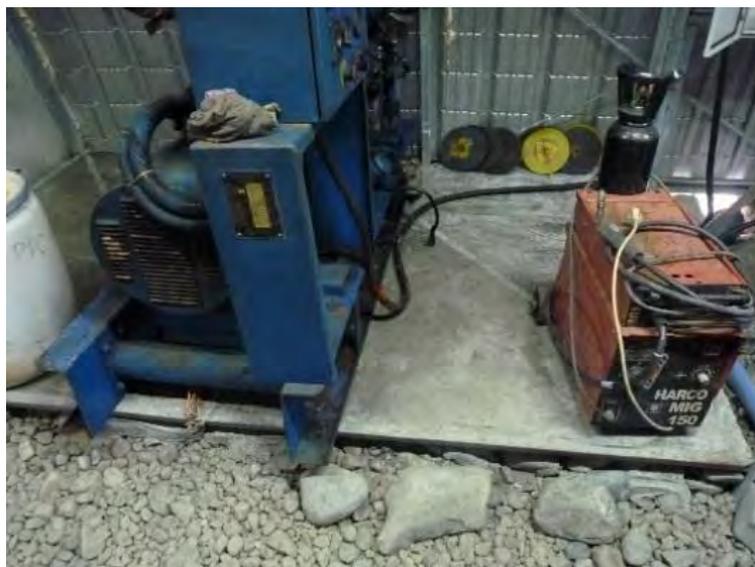
Figure 45 – Condition of the floor in the module where electric generators are located

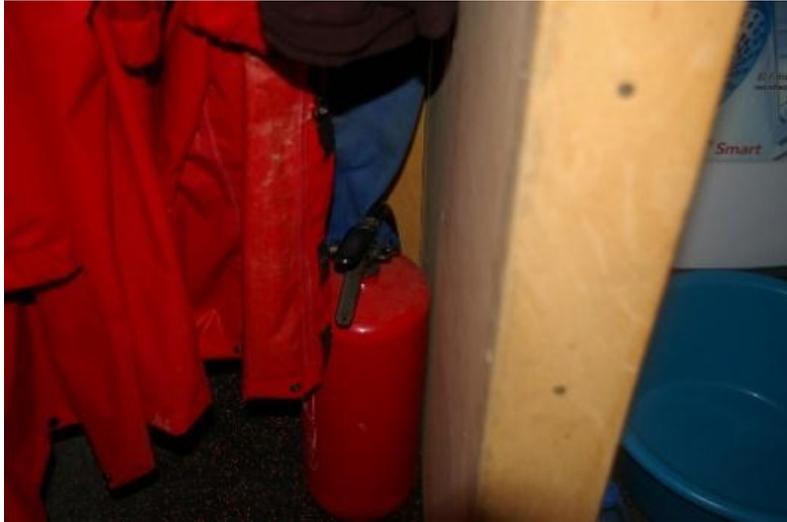
Figure 46 – Location of fire extinguisher in the main accommodation of the station.
