ANTARCTIC TREATY INSPECTIONS 2005

Report of Antarctic Treaty Inspections undertaken jointly by the United Kingdom, Australia and Perú in accordance with Article VII of the Antarctic Treaty and Article 14 of the Environmental Protocol.

**Foreign and Commonwealth Office, London, UK
Australian Antarctic Division, Kingston, Tasmania, Australia
Instituto Antártico Peruano, Lima, Peru**

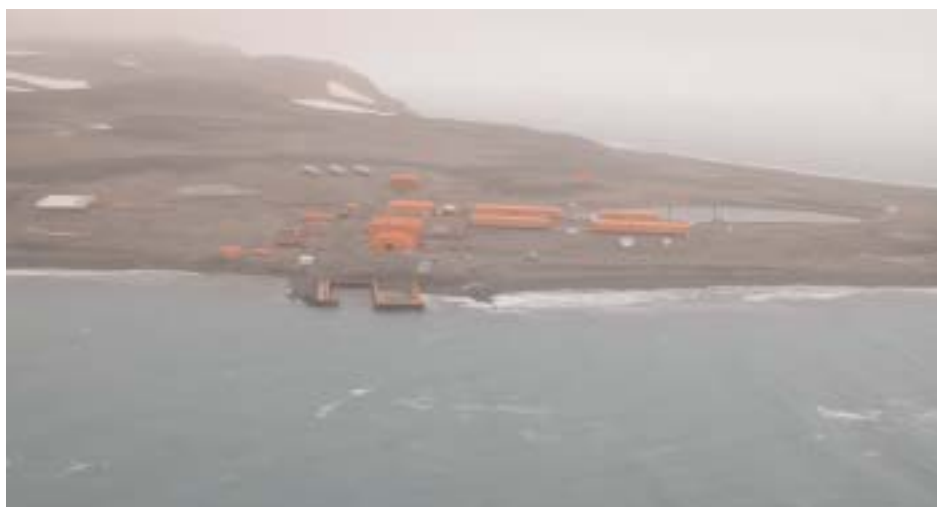
Aerial view of King Sejong Station showing the newly constructed wharf and dock in the foreground. The two sets of bulk fuel tanks are set to the left, and in the middle distance.

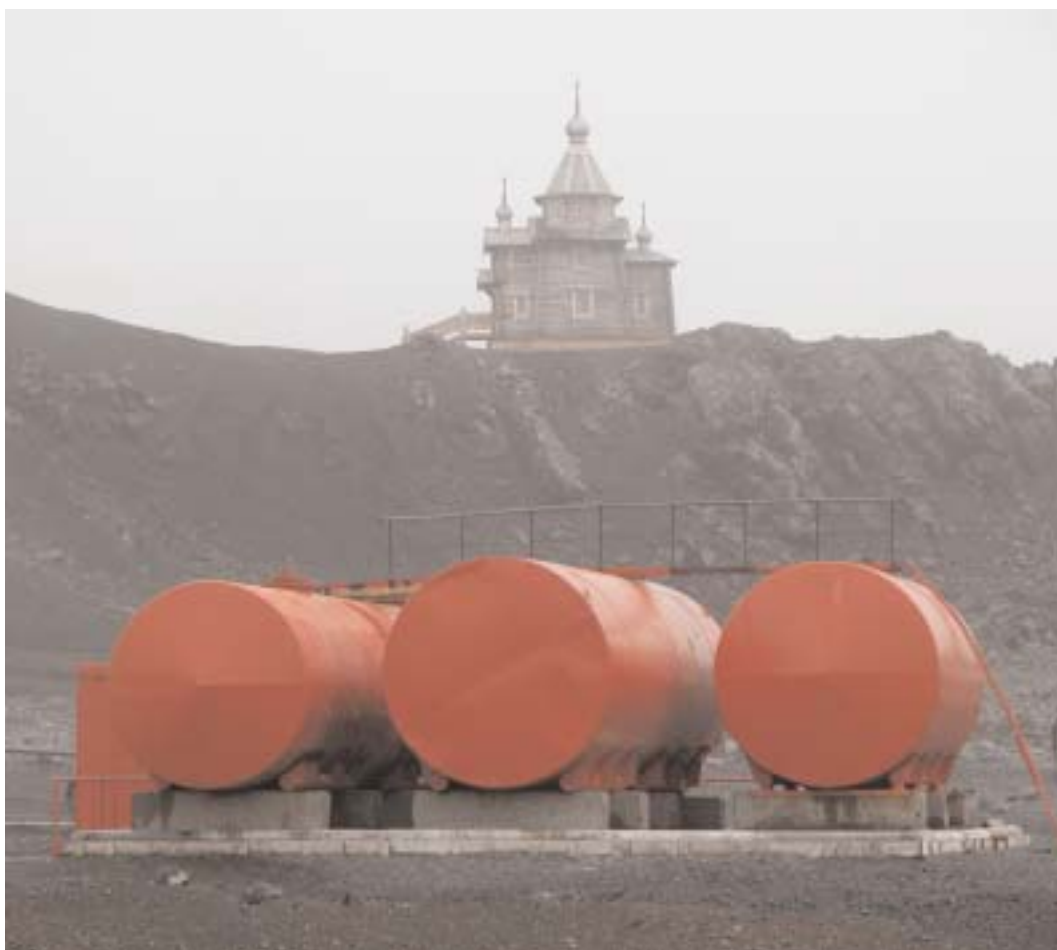
The recently constructed Russian Orthodox Church at Bellingshausen, seen over some of the station's fuel tanks

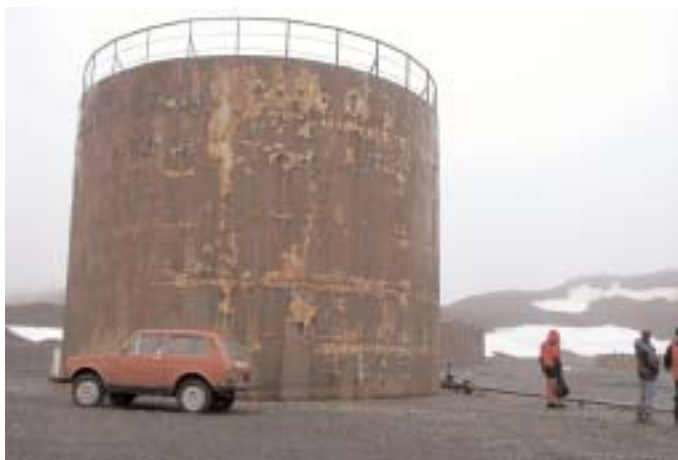
A further three tanks of similar construction but approximately 150,000 litres capacity were located at the north of the same beach: one is to be removed. The other two contain waste and recovered petroleum products. This bulk fuel storage facility was constructed in 1970/71 to supply the then Soviet Antarctic fishing fleet.

One of the large (250,000 litre) bulk fuel tanks at Rocky Cove, North of Bellingshausen.

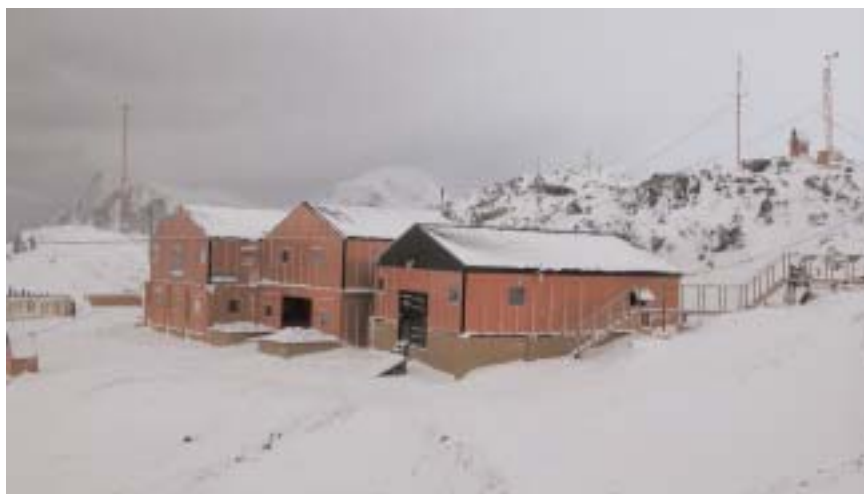
The main building complex of San Martin.

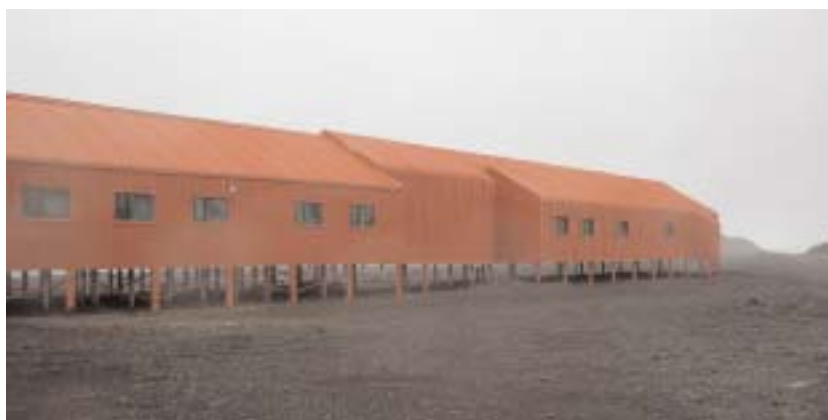
The rear

view of Maldonado Base.

The base was closed up, with doors locked and sealed, and suspended sub-floor services removed. It consists of one main building some 35-40 by 8 metres, raised one metre off the ground by steel supports and in excellent condition. An adjacent smaller building 6 by 6 metres was assumed to be the powerhouse/garage. A section of the roof of this building had been torn off, presumably by storm damage: if not repaired the building is likely to suffer much more serious damage. Both buildings are foam insulated and metal clad and appeared to be of excellent design. A fibreglass Igloo satellite cabin (“Apple” hut) was sited next to the main building.

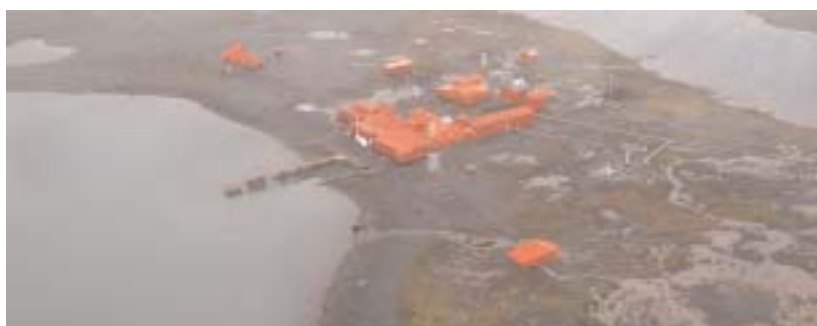
Capitán Arturo Prat Base was visited briefly by helicopter. The station is located on the eastern shore of Discovery Bay, Greenwich Island, South Shetland Islands at Lat. 62° 30’S; Long. 59° 41’W. It was unoccupied. The doors were locked and sealed, and windows boarded up. From external appearances of the buildings it would appear that they had not been occupied for at least 2-3 years. Paint was peeling off the walls and some wind damage was evident with a door torn off the ramp-shaped building to the north of the station.

An aerial view of Capitán Arturo Prat station.

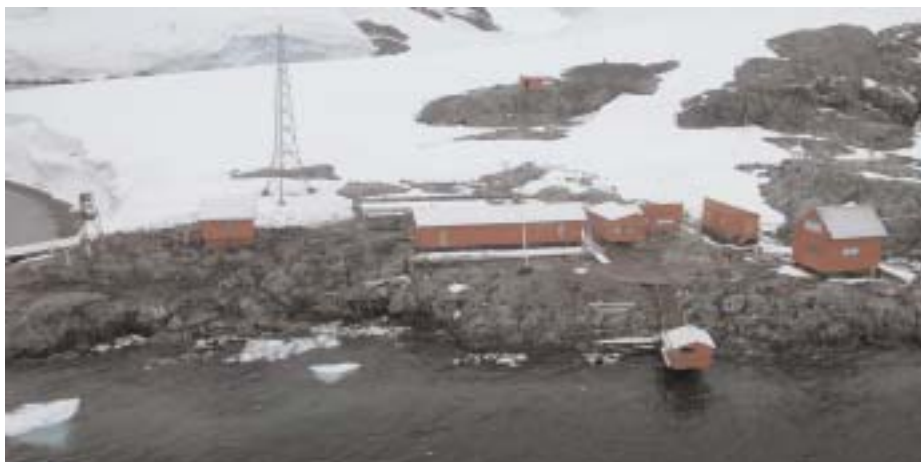
An aerial view of Almirante Brown. The bulk fuel tanks are located just out of the photograph to the right.

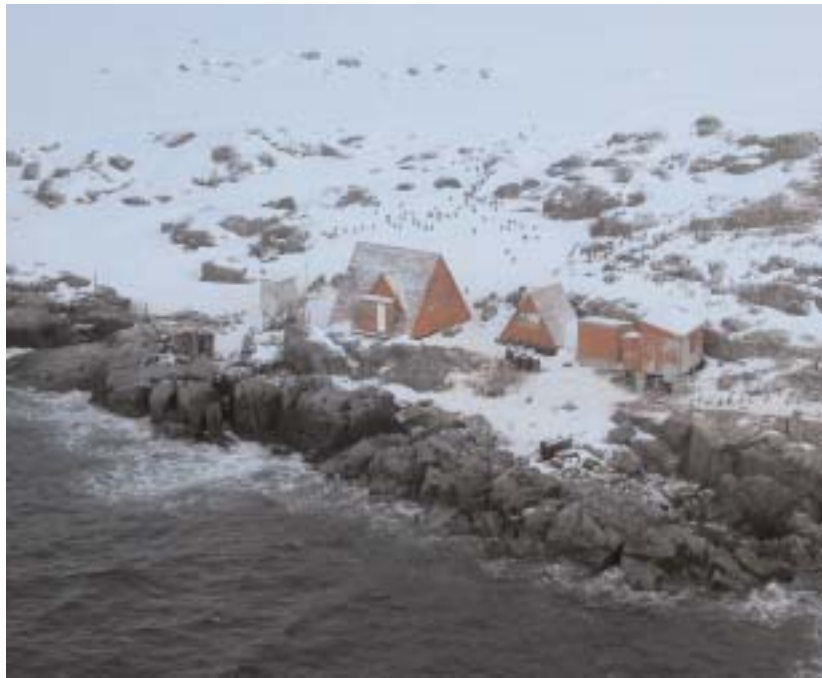
Yelcho from the air. Note the density of nesting penguins.

Although the station was unoccupied, none of the windows had been boarded up. How long Yelcho had been unoccupied was not clear. There was no evidence of any storm damage.

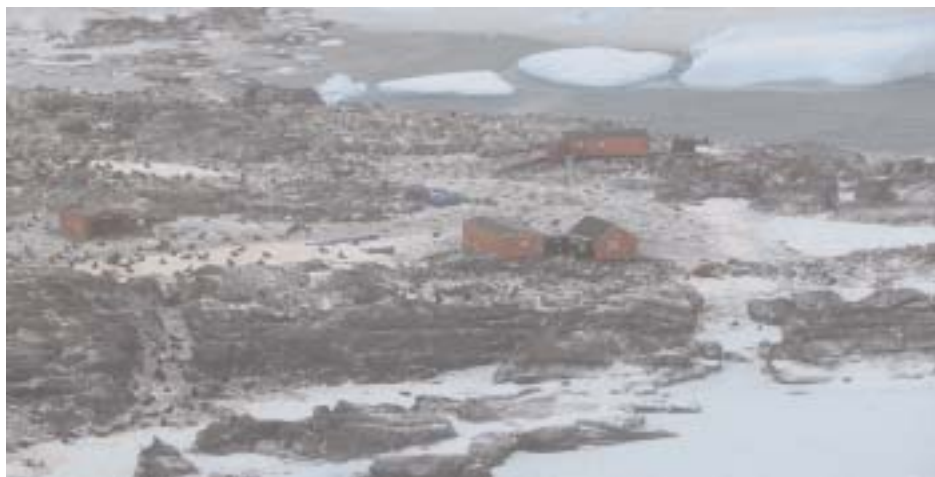
An aerial view of Teniente Luis Carvajal Villaroel. Some of the 2-3,000 fur seals present can be seen.

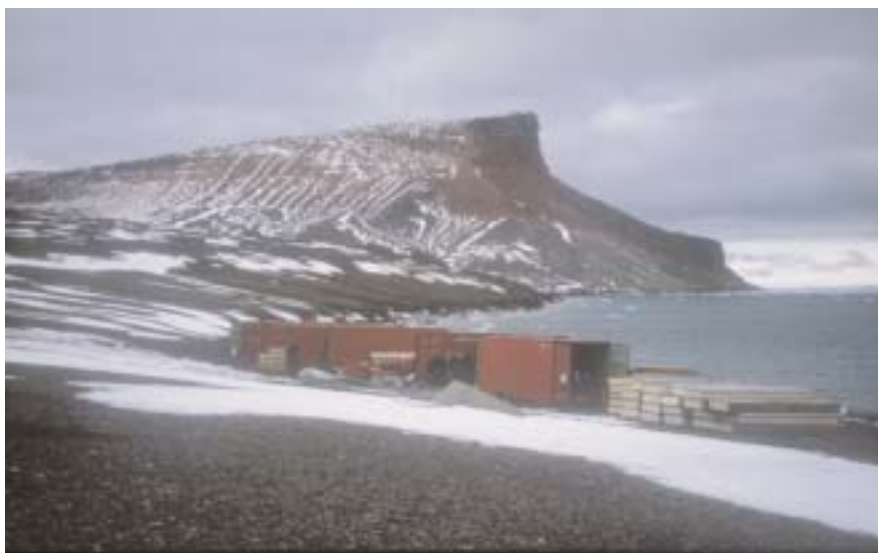
Containers offloaded on the beach for the construction of the new Czech Station on James Ross Island. Looking west towards Bibby Point.

Eight 20' ISO containers had been brought ashore by landing craft from the *Viel*, and positioned two to three metres above the shoreline. Cargo was being unloaded, and preparations were underway to set up a temporary messing tent for the construction team. Polystyrene insulated plywood sandwich panels, from which much of the station will be constructed, were stacked on the beach – some had been damaged in transit.

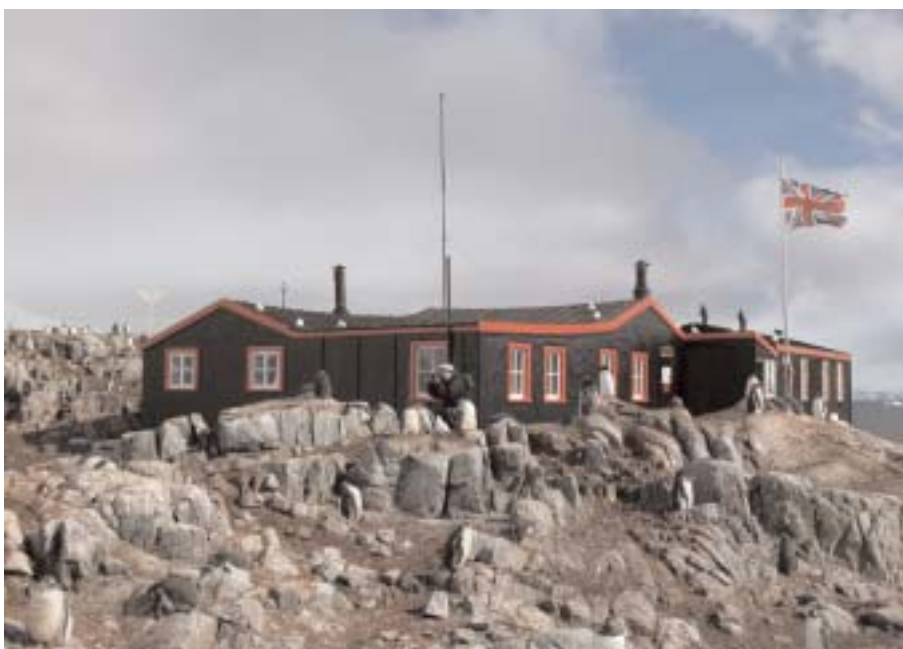
Port Lockroy Historic Site and Monument.

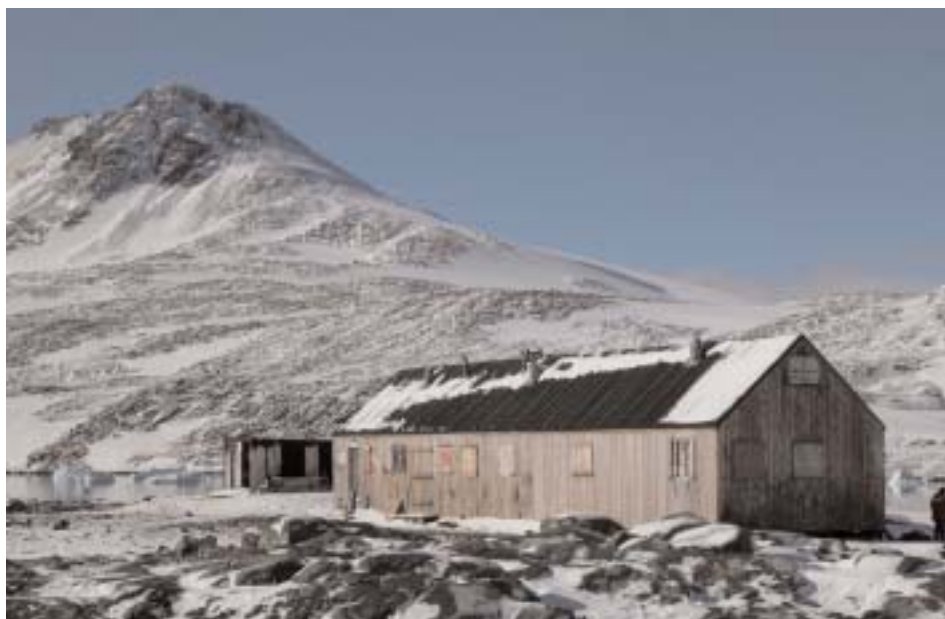
A general view of Horseshoe Island (Base Y)

'Base Y' was found to be generally in good condition. The ruberoid roofing felt was intact and securely battened down. Internally, the hut was dry and the numerous artefacts were present in an orderly fashion. Part of the roof-space had been sealed off with thick polythene sheeting and marked as 'Dangerous-Asbestos'.

Externally, the timber walls had been stripped bare of paint by wind and ice blast. Four of the windows were missing wooden shutters, and some cracks were evident in the external window panes. Two guy wires secured the generator shed and the east end of the building. A guy wire formerly attached to the middle section of the main roof span was broken and lay at the foot of the building. No guy wires were evident at the west end of the building.

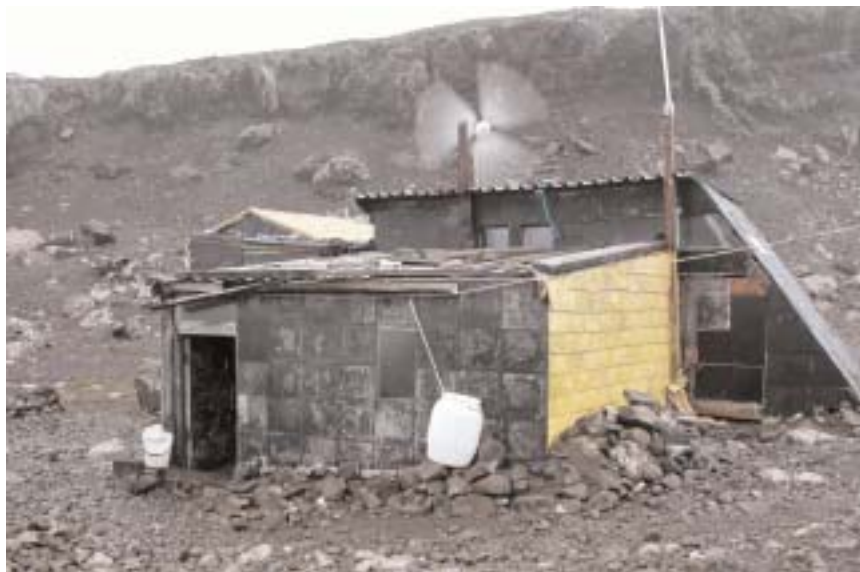
The Eco-base on Nelson Island. Note the small aerial generator.
